# **URGENT - FIELD SAFETY NOTICE**

# MAQUET VOLISTA Field Action MSA/2017/006/IU

Date: February 12, 2018

Product Issue: Detachment of the central handle holder from the VOLISTA surgical light

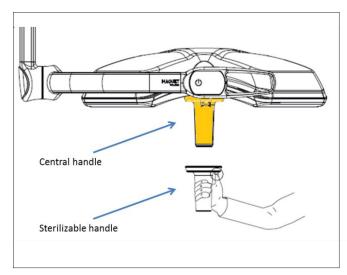
We received complaints indicating that the central handle holder detaches easily from the cupola during use. We determined that the root cause of this malfunction is excessive tightening of the screws during mounting of the handle holder, resulting in the rivets loosening and detaching from the central handle holder ring.

During manipulation, the handle holder may completely detach from the light head, if all three rivets loosen simultaneously. In this case, although the handle remains in the user's hand, small quantities of particles may be generated from the plastic holder ring. From our clinical evaluation, it was concluded that there is a remote chance that this issue may cause post-operative infection, foreign body granuloma or allergic reactions, if the particles fall into the patient's wound or on sterile equipment.

The issue was solved in production by a design change of the rivets (modification of shape and overmolding with the handle holder ring). For units manufactured before application of the modification in production, we see the issue as a potential long term hazard and want to prevent any related event from occurring with our customers. This action consists in the replacement of the existing central holder rings with the new design.
