## Urgent Field Safety Notice

### Update to address Numerical Format Issue in the CT900 Clinician Programmer via Model A810 SynchroMed™ II Software Application for Version 1.1.342 Software Update

Medtronic Reference: FA920

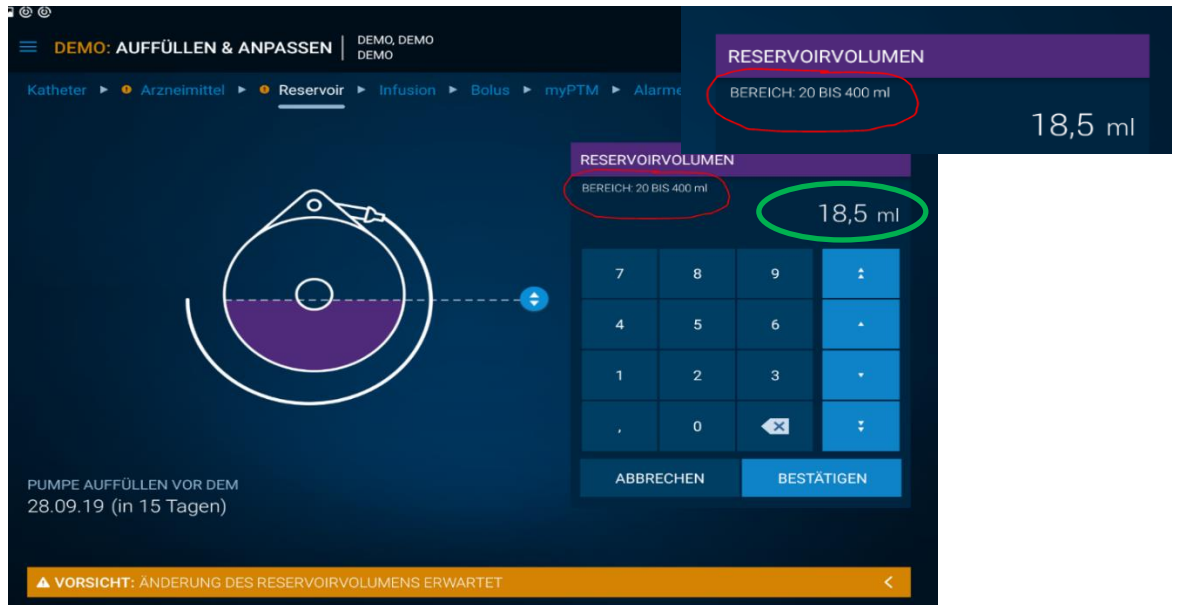
Figure 1: Incorrect values displayed for the allowed range of the reservoir volume (200 – 400 ml): Data entered by HCP is correct (18.5 ml)

Please download the latest update to the A810 SynchroMed II Software Application, version 1.1.342, to the CT900 Clinician Programmer following the enclosed instructions.

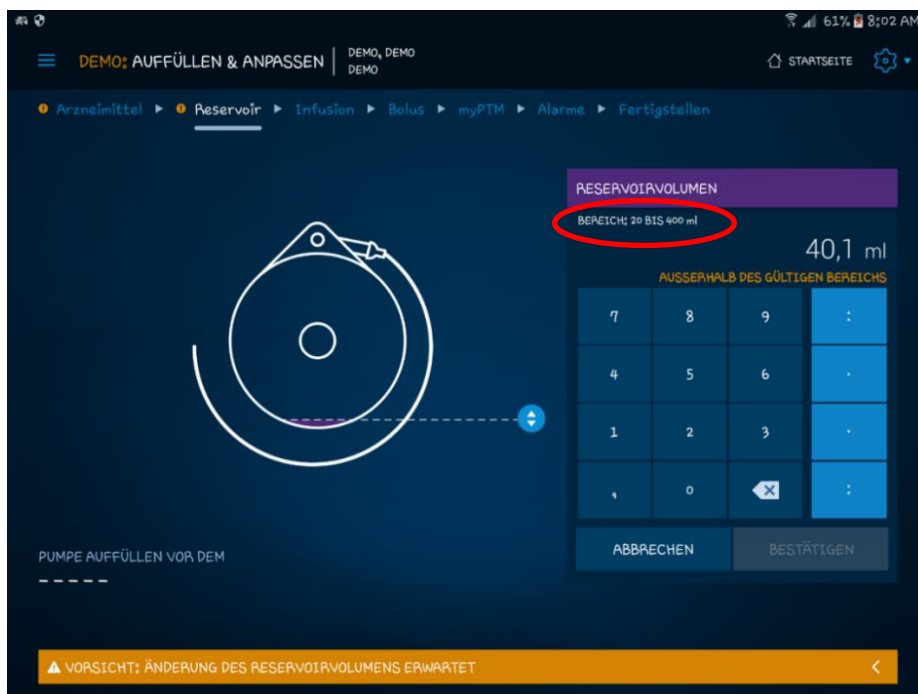
Figure 2: Value 40,1 cannot be entered even though the displayed range text indicates it can
