Urgent Device Correction

Elevated Temperature of Receive Coil Components When Using Select Ciné Treatment Imaging Sequences

UDC 2020-001

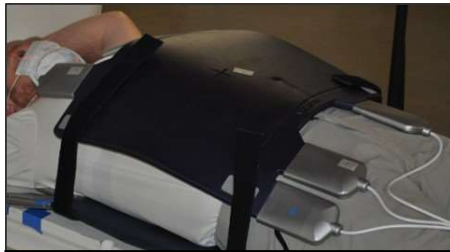
The extreme testing conditions showed that the use of 3 Plane or 8 fps cine' treatment imaging sequences while the receive coil is positioned close to the bore wall causes some of the gray plastic electronic boxes ("feedboard boxes" Figure 1 & 2) attached to the receive coil, to reach an elevated temperature. If the feedboard boxes are in contact with the patient or user, there is the potential risk of injury.

During radiation delivery, the MRIdian system continually acquires images. During this continuous imaging, the receive coils are exposed to RF energy. The amount of RF energy exposure is directly related to the cine' treatment imaging sequences being used. The higher RF energy associated with the 3 Plane and 8 fps sequences and the proximity of the coil to the bore wall contribute to the elevated temperature of the feedboard boxes.

Figure 1: Torso coil with feedboard boxes oriented toward feet

Do: Maintain a distance of at least 5 cm (~2") between the receive coil and the inner surface of the bore wall when using 3 Plane ciné treatment imaging (Figure 3 & 4).

Do Not: Select 3 Plane ciné treatment imaging if a distance of at least 5 cm (~2") cannot be maintained between the receive coil and the inner surface of the bore wall during treatment.

Do Not: Use 8 fps ciné treatment imaging until further guidance is provided by ViewRay.

Do: Use 4 fps ciné treatment imaging when treating a patient.

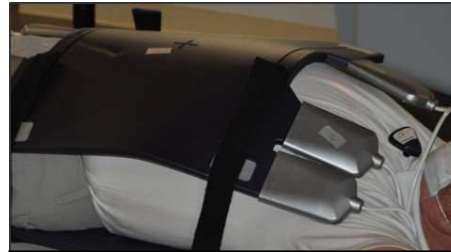
Figure 2: Torso coil with feedboard boxes oriented toward head

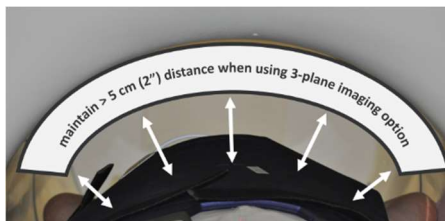
Figure 3: Distance between receive coil and inner surface of bore wall is more than 5 cm
