Carl Zeiss Meditec AG 07740 Jena

Our ref.:FCA 2020-007

FIELD SAFETY CORRECTIVE ACTION

Installation of a software update on active ZEISS IOLMaster 700 with software 1.90.2.09 and 1.90.8.06

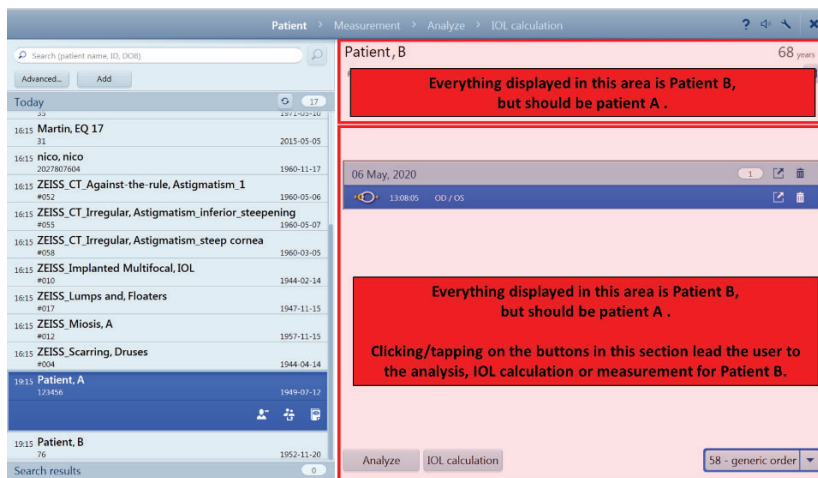
1. The user has selected patient « A » in the patient list, but patient « B » is displayed on the right side (Figure 1).
2. The user has selected patient « A » in the patient list, patient « A » is correctly displayed in the top right, but patient « B » is displayed in the bottom right (Figure 2).

Figure 1: Mismatch between patient list and right side of patient manager.

This sporadic behavior leads to a false display of patients in the patient manager screen, which can subsequently lead to the implantation of a wrong intraocular lens (IOL). Therefore, a software update needs to be installed or the MWL functionality needs to be deactivated until the software update can be installed.

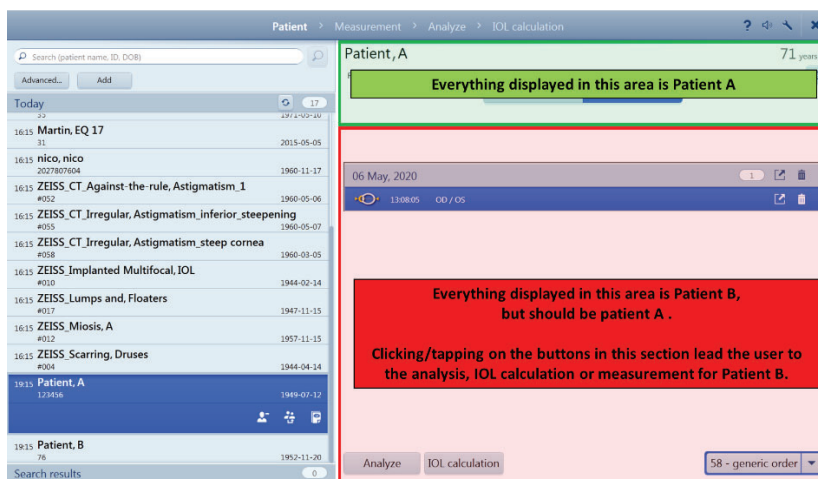
Figure 2: Mismatch between patient list / upper right side and lower right side of patient manager.
