Urgent Field Safety Notice
MiniMed™ 780G insulin pump
Pump: MMT-1885, MMT-1886
Pump Kit : MMT-1895, MMT-1896
Pump Errors After Quick Bolus

March 2021

Medtronic reference: FA963

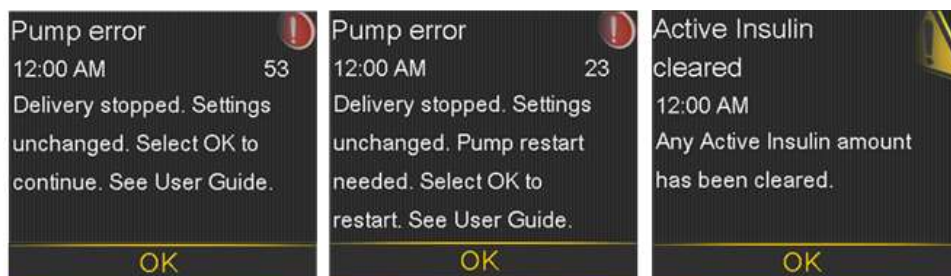
If all the above conditions are met, within 2 minutes of bolus delivery completion, the pump initiates Pump error 53, followed by Pump error 23 alarm. The following screens are presented in the pump screen:

Upon clearing the pump errors, the pump resets and indicates Active Insulin has been cleared. The pump then guides the user to resume operation in Manual Mode. The SmartGuard™ status screen

indicates the warm-up period has started. After approximately 5 hours, the SmartGuard™ feature will be available.

Since Active Insulin will display 0.0 units in the pump after experiencing the pump errors above, if the user is not aware of the amount of active insulin and delivers an additional bolus, there is a risk of insulin over delivery, which may result in low blood sugar (hypoglycemia) or severe hypoglycemia. In rare cases, severe hypoglycemia, if left untreated, may lead to a life-threatening situation. As of January 21, 2021, Medtronic has received no reports of serious patient harm or serious injury related to this issue.

1. Although insulin was delivered before the error and you may have insulin on board, Active Insulin is reset to 0.0 units on the pump screen.
2. Before delivering additional boluses, check your graph or history to understand how much insulin was delivered before the error.
3. Consult your healthcare professional about your active insulin absorption and how to plan a bolus if active insulin has been reset to 0.0.

1. **Wait** at least 2 minutes between boluses if you need to deliver multiple boluses that exceed 17.1U in total.
2. **Consult** your healthcare professional about setting your maximum bolus limit to 17U or less.
Note: The default setting is 10U.
