URGENT – FIELD SAFETY NOTICE

IndiGo Drive Assistance for Arjo beds

Product Issue: Potential failure of IndiGo Cabling

Field Safety Notice: FSN-POZ-001-2021

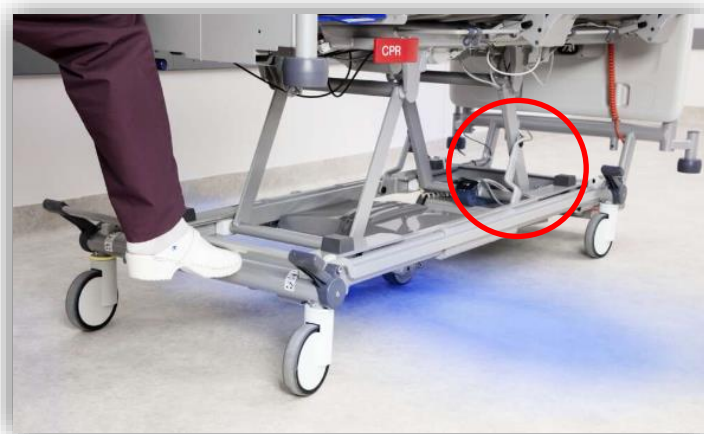
IndiGo cabling - location

Following continual monitoring of customer feedback, we have observed that the Indigo power cord might wear during use which could lead to its damage.

Arjo has received limited reports of this malfunction occurring and no reports of health consequences to either patients or caregivers. The probability of occurrence of harm is unlikely. In extreme cases, our investigations have projected, that there is a remote possibility for the transmission of current from the Indigo cabling throughout certain metal components of the bed base frame, which may result, in the worst case scenario, in electrocution.

1. Carefully verify the condition of IndiGo cabling. Check for any visible damage of the part – if any damage in the cabling is detected, remove the product from use until its retrofit is completed.
