# **URGENT:** Field Safety Notice

MOD1329

WelchAllyn GS777 Wall Transformer (all models) and PRO BP 3400 (handheld, desk mount, wall mount models)

## Subject: GS777 Wall Transformer and ProBP 3400 Potential Fluid Ingress (MOD1329)

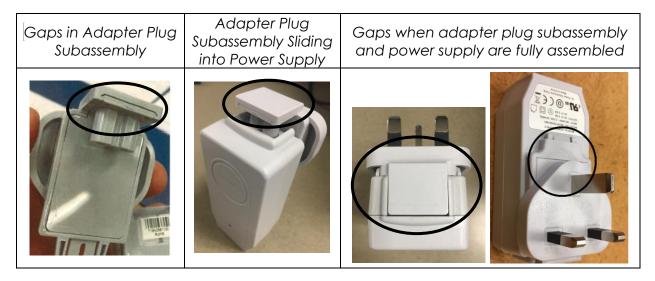
Our investigation has confirmed that the reported complaints were the result of unintentional fluid ingress into the power supply caused during cleaning.

Based on our investigation, unintentional fluid ingress is most likely to occur in the gaps of the adapter plug subassembly pictured below.

The GS777 and the ProBP 3400 power supplies are not intended to be cleaned with saturated wipes and should not be plugged into an electrical outlet when wet.

- 2. Ensure the cleaning cloth is not soaking (not dripping or over saturated) with cleaning fluid.
- 3. Apply minimal pressure on wipe when cleaning; avoid wiping gap areas identified on adapter plug as these areas are most susceptible to liquid ingress.
- 4. Ensure the power supply and power cord are dry before plugging into electrical outlet.
- 5. Hold the sides of the power supply when plugging into electrical outlet as pictured below. Avoid contact with bottom of the power supply where cleaning fluid is mostly likely to have accumulated.
