Urgent Field Safety Notice

Model A610 DBS Version 3.0.x

Clinician Programmer Tablet Application Displays System Error During Interrogation - Software Update

Medtronic Reference: FA1188

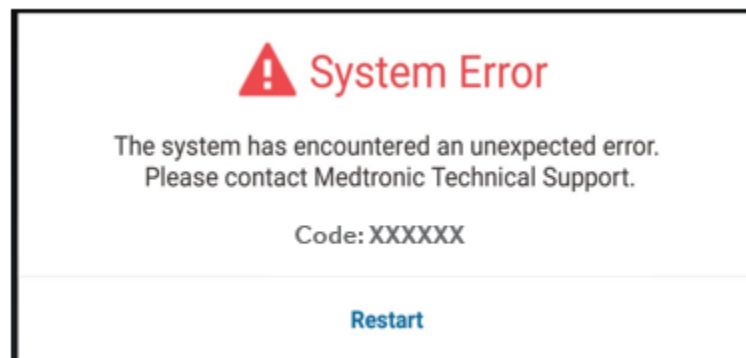
Under these circumstances, the clinician programmer application may display a recurring system error and terminate the session, preventing interrogation or programming of the device. The patient will continue to receive therapy and the patient programmer can be used to adjust therapy within clinician set limits.

If this issue occurs, you will encounter a system error message similar to the one below:

Error codes seen with this issue include, but may not be limited to, codes 0x4b81f1a3 and 0x791ebfe0.

1. Download version 3.0.1098 (or higher) of the A610 DBS Clinician Programmer Tablet Application. Your Medtronic representative can assist you with the update.
 - a. With this new A610 application version you will not experience the issue when interrogating an Activa PC or Activa RC device.
2. Share this communication within your organization, with other organizations where affected devices have been transferred, and with any other associated organizations that may be impacted by this action.
3. Maintain a copy of this notice in your records.
4. If you experience this issue, contact your Medtronic Representative to troubleshoot and coordinate appropriate next steps.

If you experience this recurring system error message, contact your Medtronic Representative. Medtronic is developing a software update to address this issue and will inform you once this is available.
