**Aptio Automation**

**Interface Module to the ADVIA® Centaur XP/XPT**

This response form is to confirm receipt of the enclosed Siemens Healthcare Diagnostics Urgent Field Safety Notice (UFSN) LASW21-01.A.OUS dated October 2021 regarding the Aptio Automation Interface Module to the ADVIA® Centaur XP/XPT. Please read the statement below and indicate the appropriate answer.

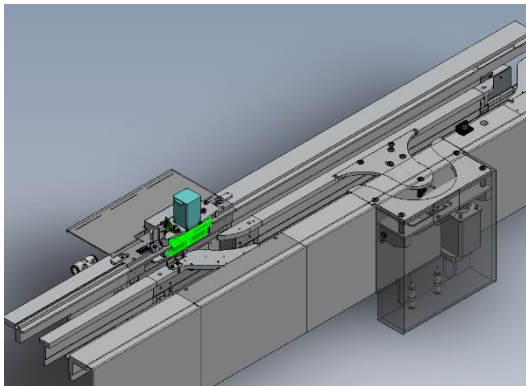
Image 1.a: ADVIA Centaur XP/XPT Interface Module  
(SMN 10703038)

- there are no obstructions that prevent the correct activation and movement of the divert, refer to Image 1.a.
- the divert looks to be intact, refer to Image 2.a.
- the position of the diverter is aligned to the profiles when it is diverting a tube, refer to Image 3.a; tubes that need to be routed by the Analyzer are diverted fluidly, without any missing or partial block of the carrier.

If the visual check does not pass, contact your local technical support for assistance.
