## Field Safety Notice

FA 2021-010-002-LUL-001

**Subject:** Missing bushing on Liko M220 and M230 causing wear and potential for falls.

**Commercial name of affected product:** Liko M220, Liko M230

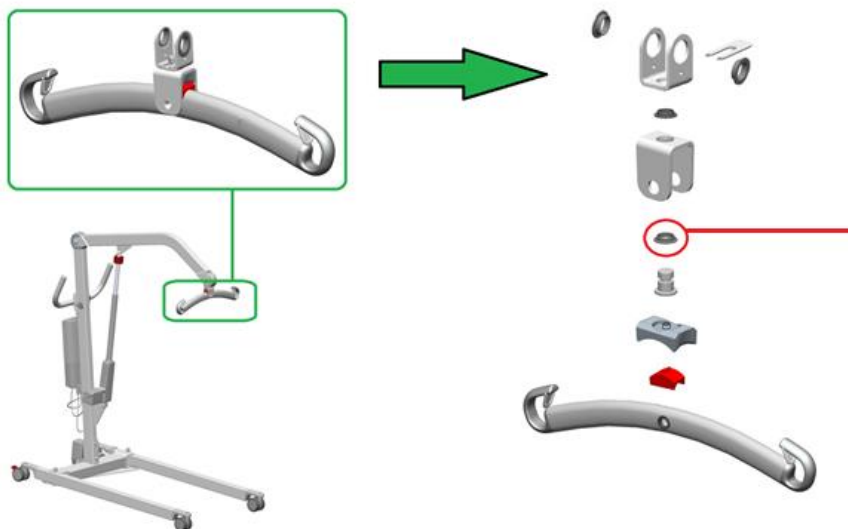
Hillrom has received customer complaints whereby a Slingbar had detached from the upper bracket of the sling bar attachment. Investigations indicated that a bushing was missing on the product. The missing bushing causes wear on the Slingbar attachment, which in turn can potentially cause the sling bar to detach from its attachment. If the slingbar detaches from the upper bracket, this has the potential for patient falls.

Figure 1: Mechanism and parts included in the sling bar for M220/M230. Bushing marked in red.

Hillrom investigation determined that the root cause of the slingbar detachment is caused by wearing at the slingbar attachment due to the missing of a plastic bushing (see red markings in Figure 1) as part of the assembly during manufacturing of the device. It was determined that assembly of this device has the potential to not contain this plastic bushing on devices manufactured between 2016-DEC-27 and 2021-SEP-01.

A missing plastic bushing on the device can cause wearing on the slingbar attachment. Over time, this wearing can cause the slingbar to detach from the lift, which may result in a patient fall. Hillrom can confirm there have been no death or serious injuries reported from this failure.

Upon receipt of the response form, identifying potentially impacted devices, Hillrom or an official Hillrom distributor/representative will be in contact to schedule inspection of your device to confirm presence of the bushing. Where it is confirmed that the device is missing the bushing, a replacement slingbar with the bushing will be installed.
