Field Safety Notice

**Philips Azurion R2.0.x System
Inadvertent change of Patient Type when the study starts**

2022-Feb-08

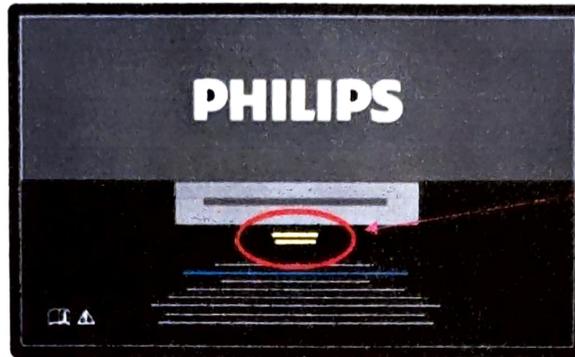
Fig. 1: System identification

The system product name and model number can be found in the System Identification Label located on the system stand (Fig. 1).

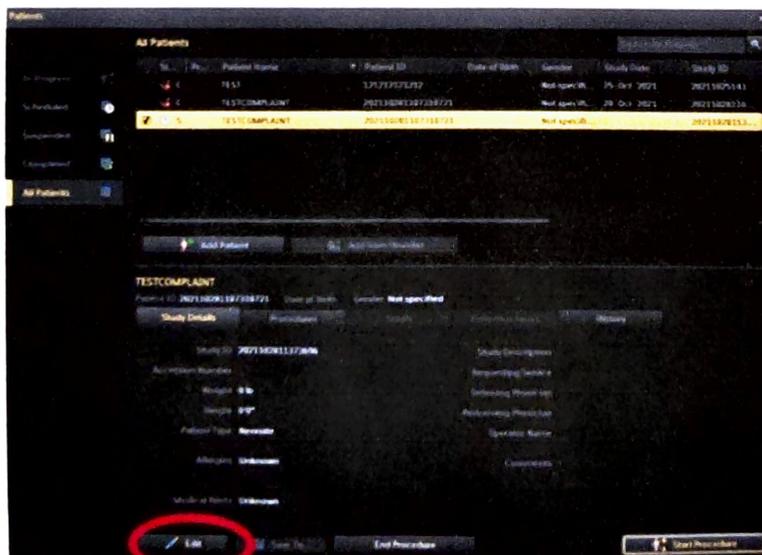
Fig. 3: Editing the Patient Type manually.

In the Azurion system, the user can add a new study to a patient by selecting the option “Add Study”. The Add Study dialogue box is then displayed where the Patient Type is selected to perform the study. Due to a software defect, when the study is initiated by pressing “Start Procedure”, the Patient Type changes inadvertently to a Patient Type different than the one selected as shown in the following Table:

- After pressing the “Start Procedure”, always edit the “Study details” and change the Patient Type before starting the Study (Fig. 3).
