Norderstedt, 31.01.2022

FSN 524700045

FIELD SAFETY NOTICE (FSN)

Fluorocell PLT

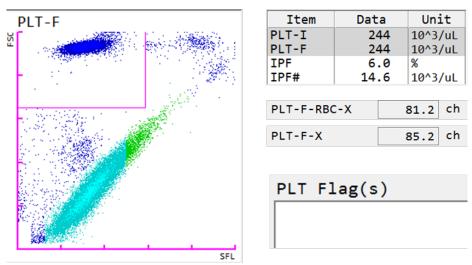
Fig. 1: Sample with a correct PLT-F classification and normal fluorescence intensity

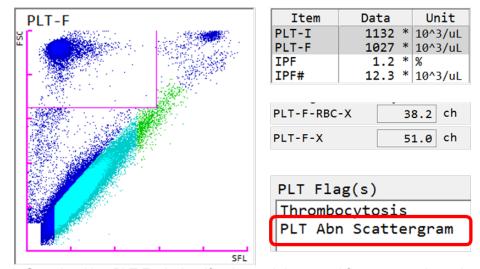
In some cases, the observed decrease was associated with an underestimation of PLT-F and IPF. The false low PLT-F value was caused by a false classification of the PLT population in the PLT-F scattergram. In the majority of these underestimated samples the flag 'PLT Abn Scattergram' was triggered.

In some cases the PLT-F population was classified as debris and thus the PLT-F results have been underestimated. This is recognisable by a dark blue coloured portion of the PLT population (please see Fig. 2). In addition, the diagnostic parameters IPF (IPF %) and IPF# (IPF count) were potentially affected as well.

Fig. 2: Sample with a PLT-F misclassification and decreased fluorescence intensity

Analyse the PLT-F scattergram for abnormalities in the classification of the PLT population, as illustrated in the example above (Fig. 2).

- 2. Check whether the PLT-F value is significantly lower than the PLT-I value, thereby potentially affecting clinical decisions.
- 3. If such a significant difference is observed causing a clinical impact, please consider whether the PLT-I value can be used, after verifying the PLT-I histogram. Alternatively, if PLT-O is calibrated, the PLT-O value can be used after verifying PLT-O scattergram (please verify with your local Sysmex representative if PLT-O has been calibrated on your analyser).
- 4. If during the plausibility check PLT-I, PLT-O and PLT-F values are questionable, perform a smear or measure PLT with the backup system available in your laboratory. For example if PLT-I and/or PLT-F are marked unreliable (*), and the PLT-I histogram and PLT-F scattergram are both abnormal, please verify results with the backup method defined in the laboratory's SOP.

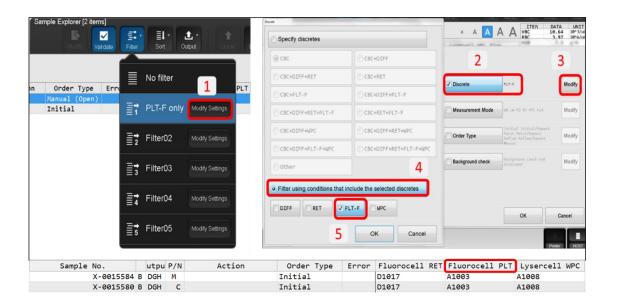
Samples can be easily filtered in the sample explorer to focus on measurements with PLT-F, and samples with 'affected reagent lots' can be identified by using the 'Reagent' tab (see Fig. 3).

Fig. 3: Filtering of samples with PLT-F measurements. The Fluorocell PLT lot can be seen in the 'Reagent' tab for each measurement
