Field Safety Notice

Philips StentBoost Live R2.0 application
Acquisition does not stop automatically
X-ray images might not be processed

2022-Feb-02

Reference: 2021-IGT-BST-033

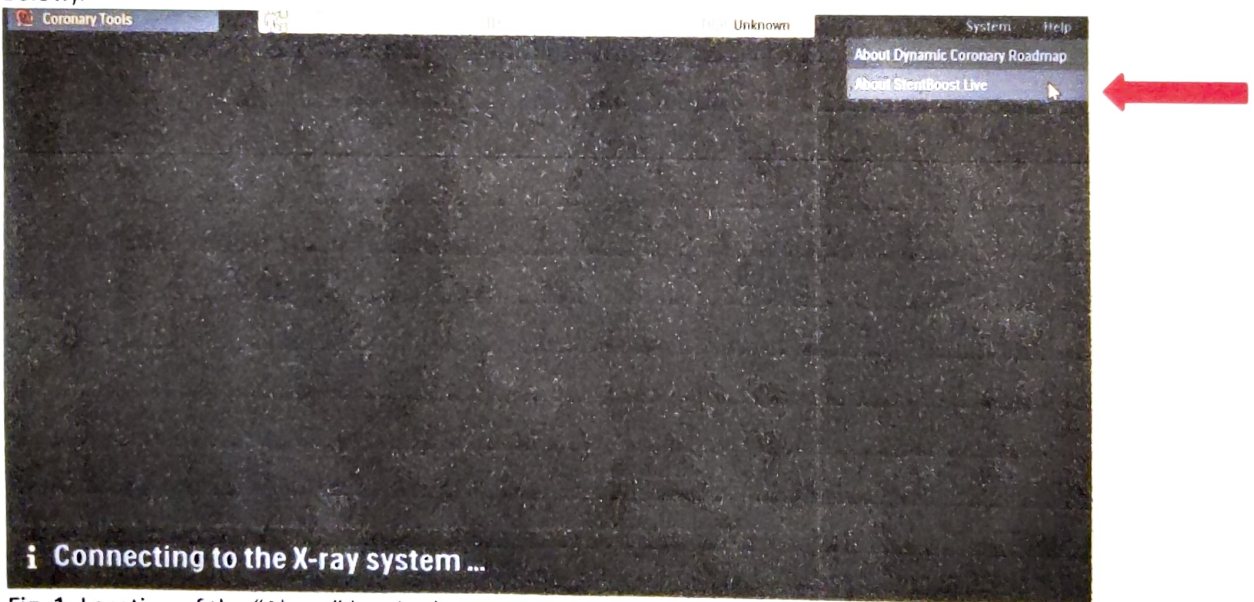
Philips StentBoost Live R2.0 application, when used with Philips Azurion with software release R2.x, is affected by these issues. The users can identify the software version of the Philips StentBoost Live application in the “About” box displayed on the screen when the application is opened (see Fig. 1 and 2 below).

Fig. 1: Location of the “About” box in the user interface.

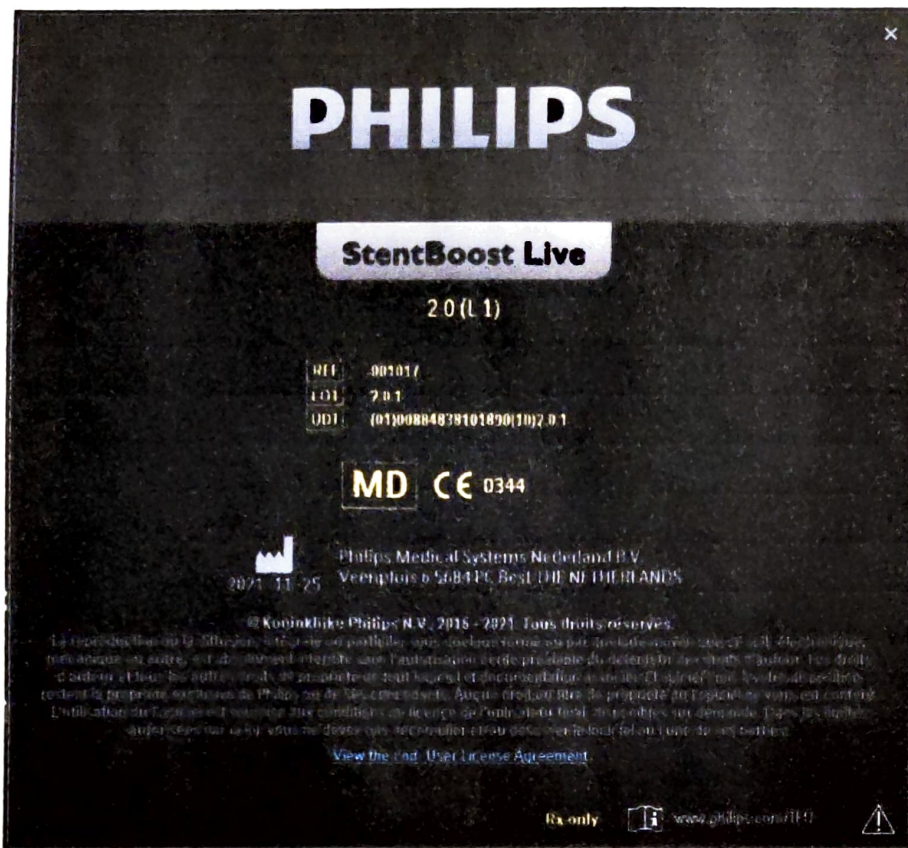
Fig. 2: Software version of StentBoost Live.

These problems will be resolved by a software update, which is already available. You will be contacted by your local Philips representative to schedule the StentBoost Live software update.
