Field Safety Notice

Philips Azurion R1.x System
 Inadvertent change of Patient Type when the study starts

2022-Mar-04

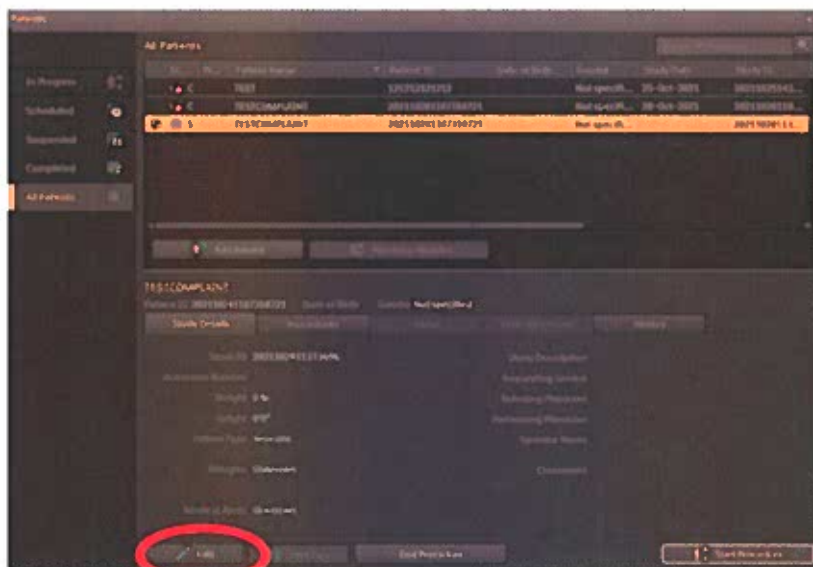
Fig. 3: Editing the Patient Type manually.

In the Azurion system, the user can add a new study to a patient by selecting the option “Add Study”. The Add Study dialogue box is then displayed where the Patient Type is selected to perform the study. Due to a software defect, when the study is initiated by pressing “Start Procedure”, the Patient Type changes inadvertently to a Patient Type different than the one selected as shown in the following Table:

- After pressing the "Start Procedure", always edit the "Study details" and change the Patient Type before starting the Study (Fig. 3).
