FSN Reference: FSN 22-004
FSCA Reference: FSCA 22-004

Re: Field Safety Notice for WiSE CRT Programmer Model 5100 Software Bug

Field Safety Notice

WiSE CRT Programmer Model 5100 Software Bug

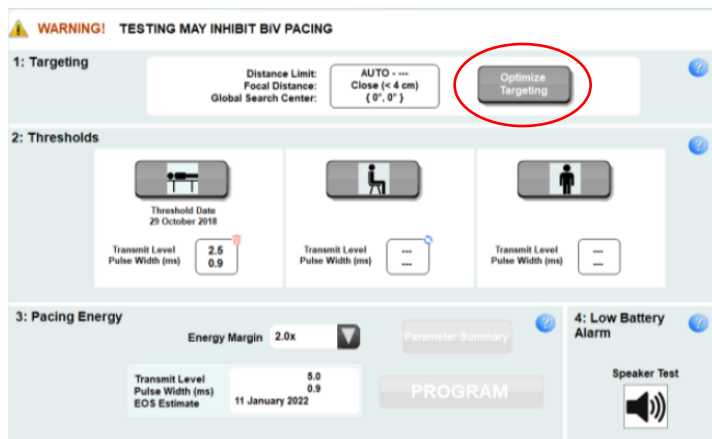
For devices programmed to utilize multiple targeting sensors, the Optimize Targeting mechanism in the FOLLOW-UP Screen (circled in Figure 1) **should not** be used as it will cause the currently active sensor to be the only enabled targeting sensor.

Figure 1: FOLLOW-UP screen with Optimize Targeting Button circled

Do not use the FOLLOW-UP screen for patients that are programmed to utilize multiple targeting sensors.

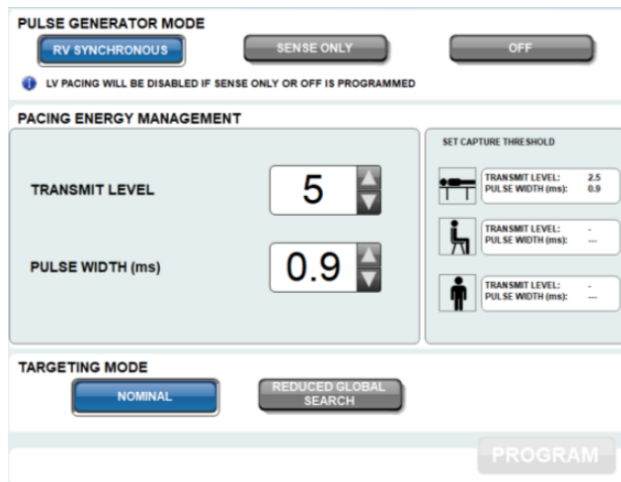
Figure 4: MODE/OUTPUT screen

If multiple sensors are enabled, targeting optimization should be performed using the ACOUSTIC WINDOW screen and threshold testing using the MODE/OUTPUT screen shown in Figure 4 rather than FOLLOW-UP screen.
