Urgent Field Safety Notice**Pump Weld Update for HeartWare™ Ventricular Assist Device
(HVAD™)**

Model	Product Description
1104	HVAD™ Pump Implant Kit
MCS1705PU	HVAD™ Pump Implant Kit

July 2022

Medtronic Reference: FA1243 Phase III

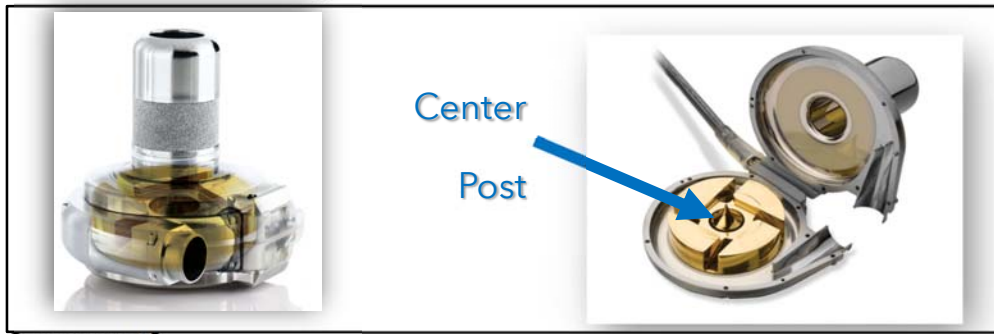
Figure 1: Pump Assembly

Medtronic is providing this letter as a follow-up to our April 2022 communication titled “Urgent Medical Device Correction” (attached), which communicated a pump weld non-conformance with the HeartWare™ Ventricular Assist Device (HVAD™) System where (3) pumps were identified to have an impeller rotating non-concentrically and contacting the center post of the pump (see Figure 1: Pump Assembly). Medtronic’s investigation was not able to conclusively isolate this issue to a specific subset of pumps. This communication provides updated information on the number of events, additional event details, and root cause.

The investigation has determined that the occurrence of a weld crack is the result of a combination of factors that may include the initial presence of contamination in the weld area from previously applied substances as part of the manufacturing process, the misalignment of the cap and housing prior to welding, or the depth/thickness of the weld. Medtronic's investigation employed multiple methods to isolate the issue to a specific subset of pumps including quantifying weld thickness, alignment

Consistent with the April communication, **routine prophylactic explant of the HVAD device is not recommended**, as risks associated with explantation may outweigh the potential benefits of continued HVAD therapy.
