23.05.2022

URGENT FIELD SAFETY NOTICE

Tibial Components / Modular Joint Component Units of Endo-Model – M Modular Knee Prosthesis System

Tibial Components of Endo-Model SL Rotational and Hinge Knee Prosthesis System

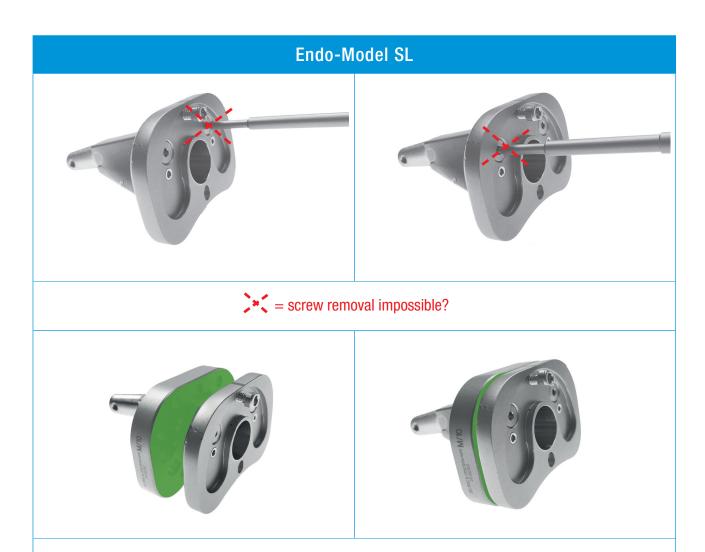
If a Tilastan proximal spacer is to be used and either one or both blind screws of the modular tibial component cannot be loosened, then the following modified surgical technique is to be performed.

It has to be observed that a homogenous cement mantle between the Tilastan proximal spacer (full & half) and modular tibial component is ensured. The cement mantle should be 1-2 mm thick.

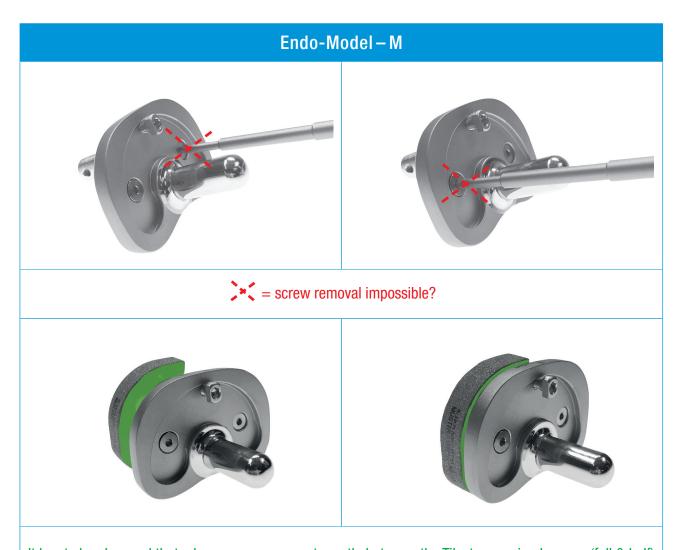
If a Tilastan proximal spacer is to be used and either one or both blind screws of the modular tibial component cannot be loosened, then the following modified surgical technique is to be performed.

It has to be observed that a homogenous cement mantle between the Tilastan proximal spacer (full & half) and modular tibial component is ensured. The cement mantle should be 1-2 mm thick.
