**URGENT Field Safety Notice**

BiPAP A30, BiPAP A40 and OmniLab Advanced+  
Motor Stator Material Non-Conformance

**Reference: 2022-CC-SRC-005**

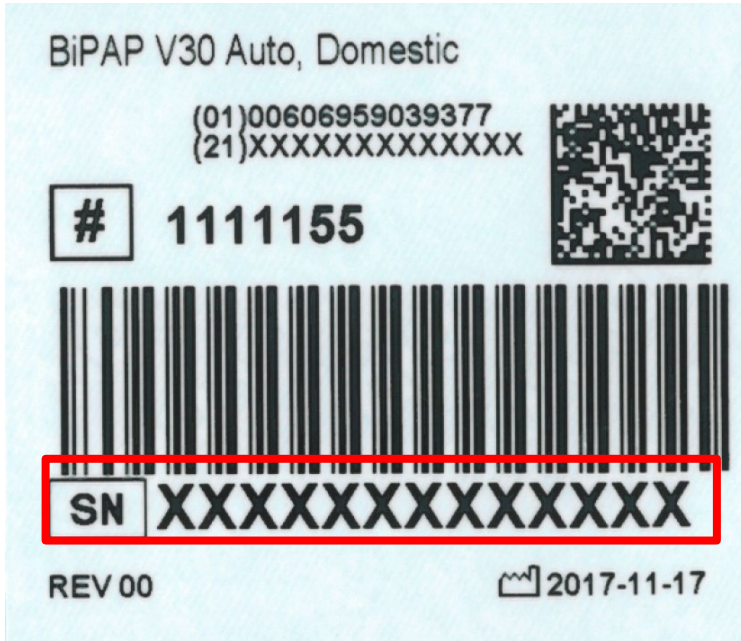
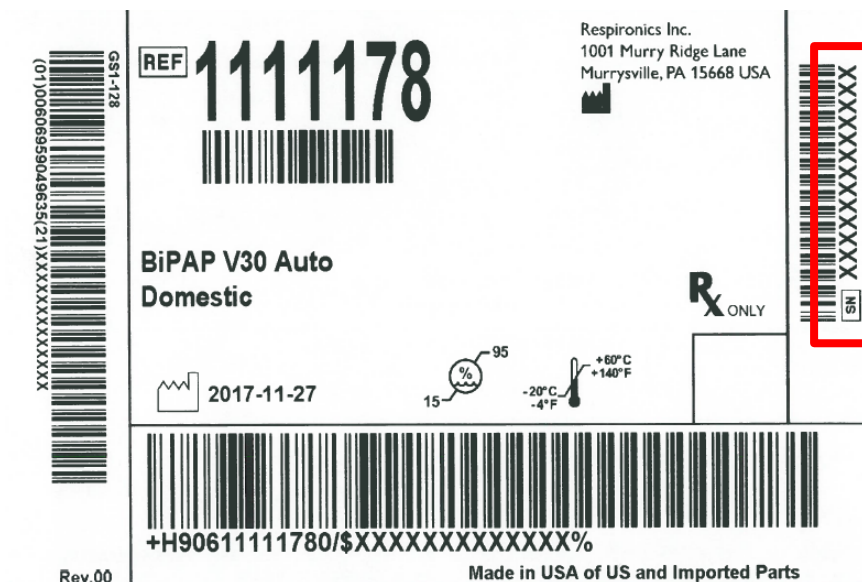
Your device is part of the impacted population if the device serial number matches any of the serial number listed on the attached. The device serial number is located on the bottom of the device on the product label or on the device packaging label as shown below.
