**URGENT - FIELD SAFETY CORRECTIVE NOTICE**

**GETINGE ED-FLOW, Automated Endoscope Reprocessor (AER)  
Field Action CAPA 657027**

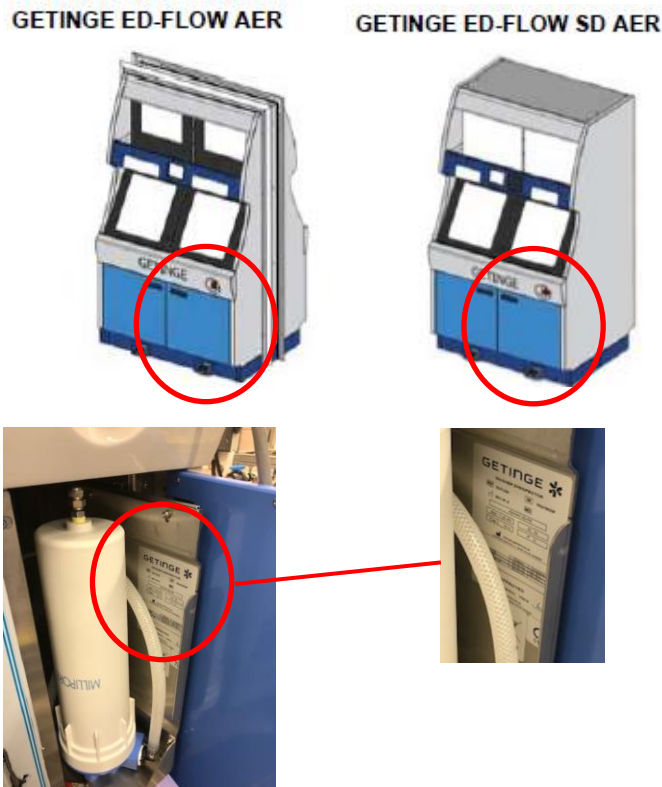
1. Check the serial number of the ED-FLOW AER. The serial number shall correspond with the serial number on the customer response form (Appendix 1).  
The serial number can be found on the marking label, located on the inside of the right Panel door, see below.
