URGENT IMPORTANT FIELD SAFETY NOTIFICATION

Subject:	A reconstruction error may occur when using the Catheter Bending functionality in Applicator Modeling or Implant Modeling
Product:	Oncentra® Brachy
Scope:	Oncentra® Brachy version 4.0 and higher In combination with: Applicator Modeling or Implant Modeling
Notification Released:	November 2022
UDI Reference:	08717213052758, 08717213038660, 08717213020610, 08717213052321, 08717213052314, 08717213052307, 08717213052291, 08717213052246, 08717213052239, 08717213051881, 08717213051843, 08717213051782, 08717213051775, 08717213051294, 08717213020610, 08717213053717, 08717213053700

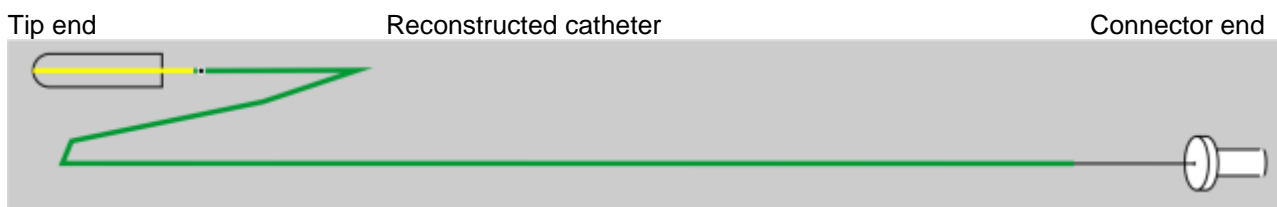
In a rare situation, a reconstruction error may be introduced by Oncentra® Brachy to an existing catheter reconstruction, when using the catheter bending functionality. Erroneously placed reconstruction points may be added that create a double kink in the reconstruction (see Figure 1). If unnoticed, this reconstruction error can result in a difference between the dose distribution in the treatment plan and the delivered dose distribution.

Figure 1. Illustration (not to scale) of the double kink reconstruction error that may be introduced in a rare situation

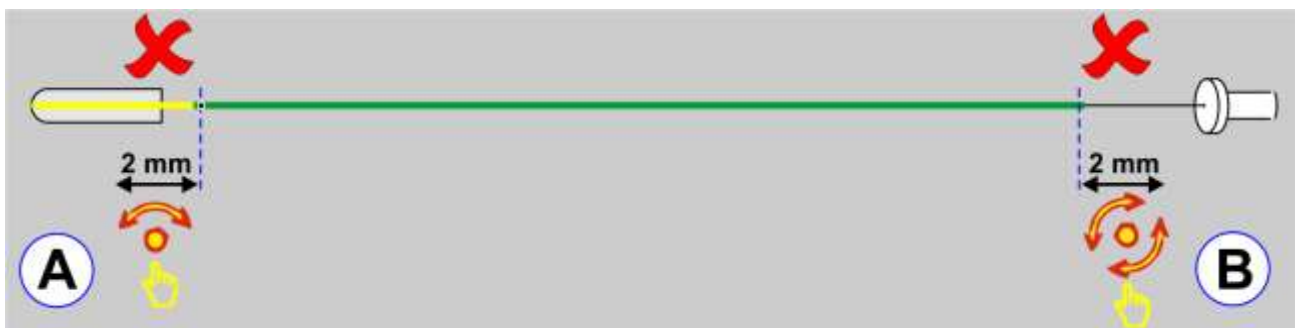
- A. At the tip end: when you position the Bending Indicator beyond the most distal reconstruction point. The Bending Indicator (semi-circle with arrowheads) should not be positioned in the 2 mm area beyond the last catheter point or in the tip end (yellow line in Figure 3). Instead, it should be positioned within the green area as indicated in Figure 4.
- B. At the connector end: when you position a Bending Point beyond the most proximal reconstruction point. The Bending Point (circle with arrowheads) should not be selected in the 2 mm area beyond the first catheter point at the connector end (black line in Figure 3). Instead, it should be positioned within the green area as indicated in Figure 4.

Figure 3. Scenarios A & B in which the use of the Catheter Bending functionality can lead to the introduction of a reconstruction error.
