URGENT - Field Safety Notice

Liver Assist Dual Set

Quality defect - potential leakage of set

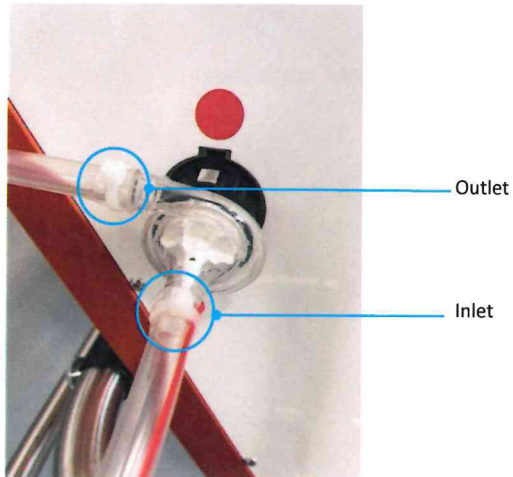
Figure 1: connections of the pump head

In rare cases, leakage could occur at the tubing connections of the pump head. Each perfusion set contains two pump heads with both an inlet and an outlet. The potential leakage can be determined already during priming when high pressures are applied. The leakage can be noticed by drop formation or persistent air bubbles at the tubing connections of the pump head

1. During priming, carefully check the connections at each pump head (4 in total). Check the inlet side for potential air bubbles in the solution or leakage. Also check the outlet side for potential leakage of solution. When handling the pump head do not extensively pull the tubing or connections.
2. If above issues are observed during priming, you can choose to replace the cable tie of the affected pump head or replace the full set.
3. If replacing the full set, save the affected set as it needs to be returned for investigation and refund.
4. If no leakages or persistent air bubbles are observed the perfusion set can be used as intended.

For an experienced user, the affected connection at the pump head can be improved by replacing the cable tie. This should take place before placing an organ on the device. Take notice that the recommended size of the new cable tie is smaller (3,5 mm instead of the current 4,6 mm).
