Urgent Field Safety Notice

Affinity Fusion™ Oxygenator Temperature Monitoring Adapter

Medtronic Reference: FA1302

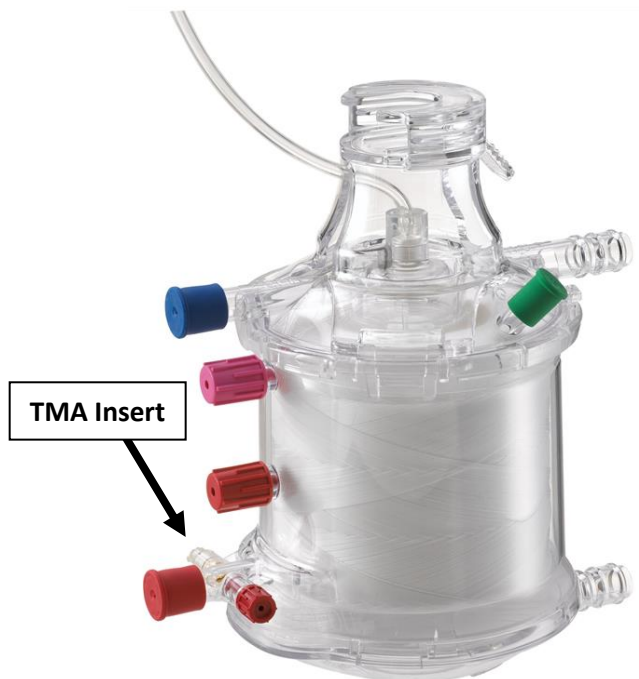
The complaints indicate that the TMA (see Image 1 for the TMA location) had come loose from the oxygenator either during pre-procedure perfusion set-up or post-procedure when disassembling the perfusion circuit.

Image 1 - TMA location on the Affinity Fusion Oxygenator

Since 02 August 2021, there have been 83 complaints globally of TMA separation from the oxygenator, with 70 reported from 07 November 2022 to 26 January 2023. The investigation to date indicates reduced connection strength for TMA connections made in the past 17 months, resulting in detachment prior to or

- Option 1: Continue to use the Affinity Fusion Oxygenator without using the TMA – use other conventional perfusion circuit temperature monitoring methods; or
- Option 2: Continue to use the Affinity Fusion Oxygenator and the TMA for arterial temperature monitoring. Ensure there is minimal torque applied to the oxygenator TMA when attaching or detaching the Temperature Probe (Product Number ATP210). Also, minimize manipulation of the TMA-probe connection during the clinical procedure.

If the TMA comes detached before the procedure setup or priming, discard the product. If the TMA comes detached during the procedure and an oxygenator replacement is decided, follow the Instructions for Use (IFU), Emergency Oxygenator Replacement section. If the TMA comes detached after the procedure completion, no additional action is required.
