**URGENT FIELD SAFETY NOTICE**

**FSCA Reference:** 617044 - HCU 40 - additional preventive measures

**Affected Product:** Heater Cooler Unit HCU 40, High Voltage (article number 701044054)  
Heater Cooler Unit HCU 40, Low Voltage (article number 701054917)

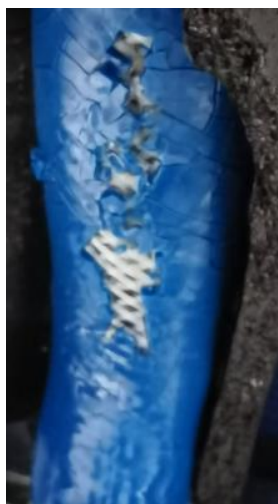
The failure mode degradation was reported for several HCU 40 system drain hoses made of Polyurethane (PUR) (see Figure 1 and Figure 2). However, on closer inspection, the tank drain hose was affected most. It is located under the water tank and follows an S-shape between the compressor and the transformer to the bottom of the HCU 40. This hose is required for emptying the water tank when replacing the system water or when draining disinfecting or descaling solution. The tank drain hose as well as the other internal blue drain hoses are inside the device and not accessible for the user.

Figure 1: Degraded drain hose

An internal investigation concluded that the tank drain hoses inside the unit do not withstand the expected service lifetime of the device of 10 years due to limited resistance of the PUR hose material against residual disinfectant Chloramine-T. In case of incomplete disinfection procedures of the water circuits, i.e., insufficient rinsing, residuals of the chemical agent can remain within the tank drain hose forcing its degradation. The material stress on the hose is furthermore increased due to heat dissipation of the compressor located nearby. Both material stress factors lead to degradation may ultimately resulting into leakage of the hose. The statistical reliability analysis revealed that, with 95% confidence, the probability of HCU 40 malfunctions due to degraded drain hoses within the expected service life is between 2.1% and 4.3% per year.

- Replacement of the tank drain hose **during every annual preventive maintenance** until the new material is approved.
- Application of the Armaflex isolation to the tank drain hose on the compressor level **during every preventive maintenance** until the new material is approved in order to protect the hose from heat stress of the compressor.

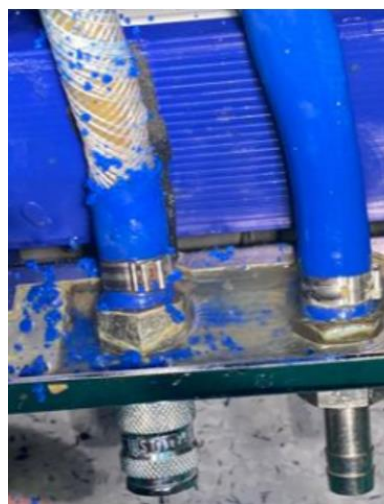
Figure 2: Degraded vs. intact blue colored hose
