URGENT Field Safety Notice

Patient Information Center (PIC iX) and IntelliVue MX40
DHCP lease expiration re-connectivity issue between IntelliVue MX40 and PIC iX

26-Apr-2023

Reference: CR # 2023-CC-HPM-006, Patient Information Center (PIC iX) and IntelliVue MX40 DHCP lease expiration re-connectivity issue between IntelliVue MX40 and PIC iX

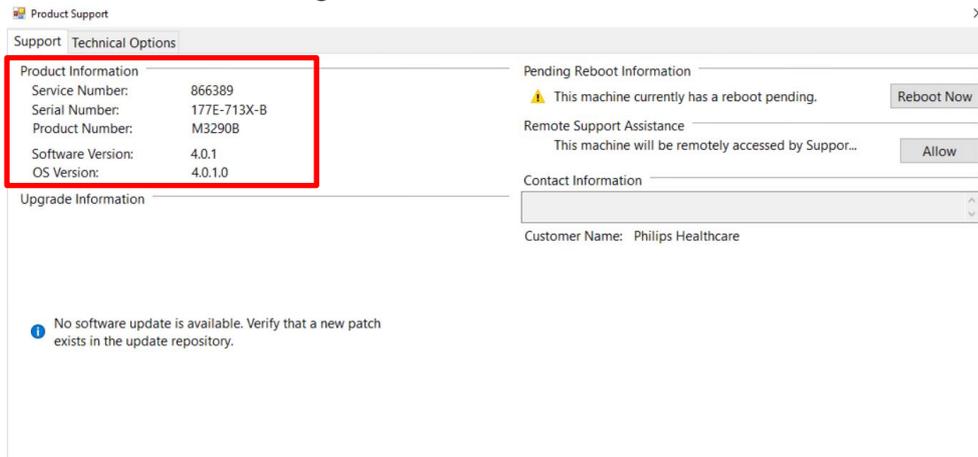
Image 1 – Software Version Identification

Access the **Product Support** screen by clicking the **Philips** icon in your application. The PIC iX Software Serial Number and Software Version appear on the **Product Support** screen in the **Product Information** Section under **Serial Number** and **Software Version** respectively. Refer to Image 1 below:

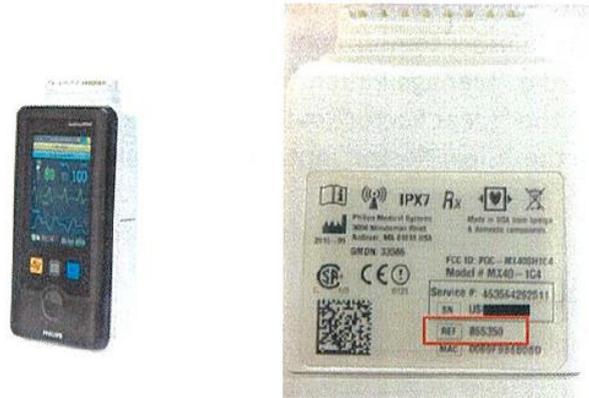
Image 2 – MX40 device and rear label

The MX40 can be identified by finding the Product Code listed on the label on the back of the MX40. The Product Code is listed under REF.
