To our customers of the
Emergency and Transport Ventilator
Oxylog 3000 *plus*

Important Safety Notice

Oxylog 3000 *plus* may not switch to mains supply following battery operation.

All Oxylog 3000 *plus* devices Part No 5704811 and 5704813,
Basic UDI DI 040486751304015FK19Z000XW, may be affected.

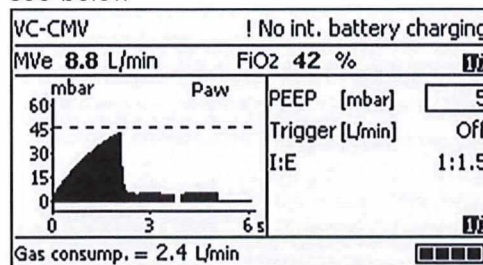
The root cause of the inability to switch to mains supply could be identified as a problem of the charging circuit which can occur in the following sequence of situations:

1. a prior battery issue indicated by the alarm "No int. battery charging" occurred during use on mains supply – see below

2. the internal battery is NOT removed and reinserted or replaced as recommended as remedy for this alarm message according to the Instructions For Use (IFU) and
3. the device is disconnected from mains supply (e.g., for patient transport) and
4. the device is reconnected to mains supply.

Please make sure that the battery is always removed and reinserted or replaced after occurrence of the **"No int. battery charging"** alarm message, without removing the device from mains supply.
