**URGENT FIELD SAFETY NOTICE**

**Subject:** 812435 - Replacement of Rotaflow II drive closing cover

**Affected Product:** 701074622 Rotaflow II drive (flex)  
701074623 Rotaflow II drive (compact)

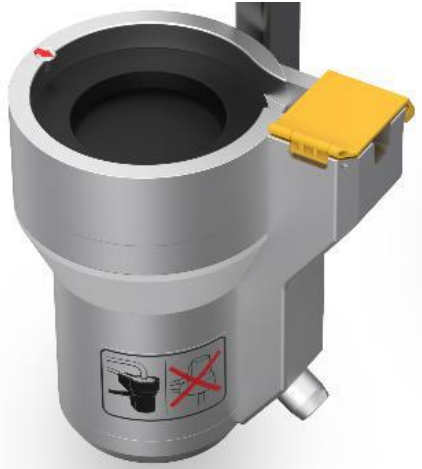
Figure 1: Rotaflow II Drive

The technical function of the Rotaflow II Drive (Fig. 1) is to drive disposable ROTAFLOW centrifugal pump (RF-32 disposable) within an extracorporeal circulation. This RF32-disposable is retained inside the Rotaflow II Drive by a locking mechanism (yellow locking mechanism, shown in Figure 1).

In October 2022 Maquet Cardiopulmonary received a complaint on issues connected to the yellow locking mechanism unlocking on patient transfer and requiring a low force to unlock.

An internal investigation identified that material behavior (strain, rigidity, etc.) is subject to change over time and a reduction of unlocking force over multiple use cycles occurs.

The noticed error can potentially cause an accidental release of the RF-32 disposable, falling out of the drive and causing pause or end of treatment.

- Action to be taken by manufacturer:**
- replacement of yellow locking mechanism with the black Rotaflow I locking mechanism by Getinge representatives (the black locking mechanism is equivalent to the Rotaflow I Drive locking mechanism)
