URGENT Field Safety Notice

MD Eleva systems
Potential loss of imaging functionality resulting from no or intermittent X-ray radiation initiation through the wired foot switch

15-August-2023

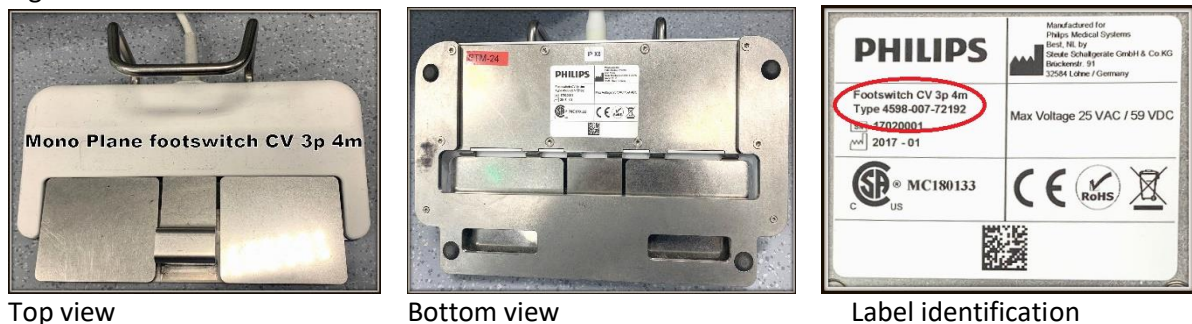
The reference/type of the wired foot switch can be found on the label located on the bottom of the wired foot switch, as shown in Figure 1.
