URGENT Field Safety Notice

Allura Xper, Allura Centron, and Azurion systems
Potential loss of imaging functionality resulting from no or intermittent X-ray radiation initiation through the wired foot switch.

15-August-2023

Reference: 2023-IGT-BST-004: Allura Xper, Allura Centron, and Azurion Systems.

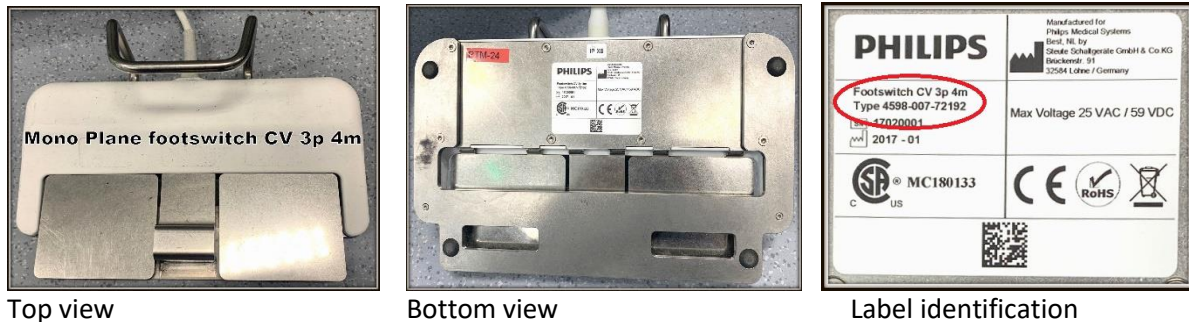
The reference/type of the wired foot switch can be found on the label located on the bottom of the wired foot switch, as shown in Figure 1.

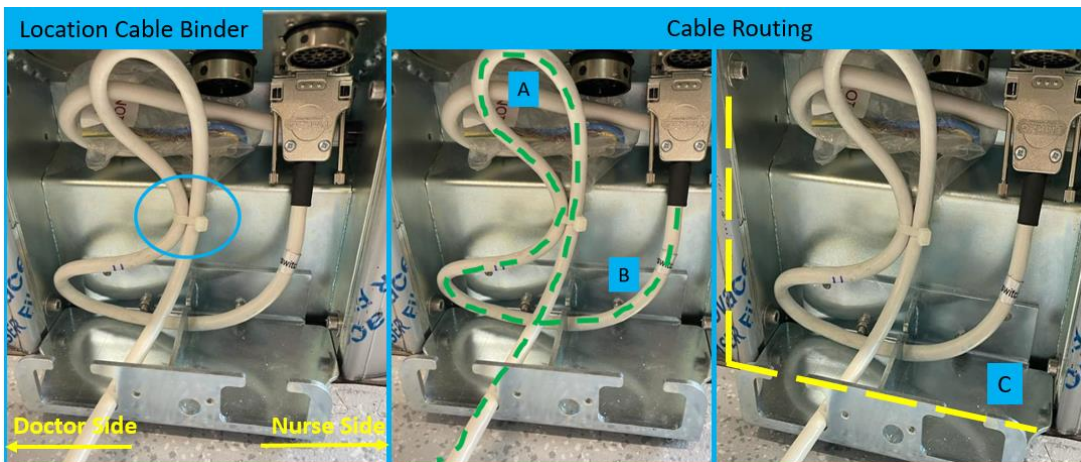
Figure 3: AD7 Patient Table

Number of cable binder(s): 1 (one)

If strain relief or routing is not correct, repair according to the repair instructions.

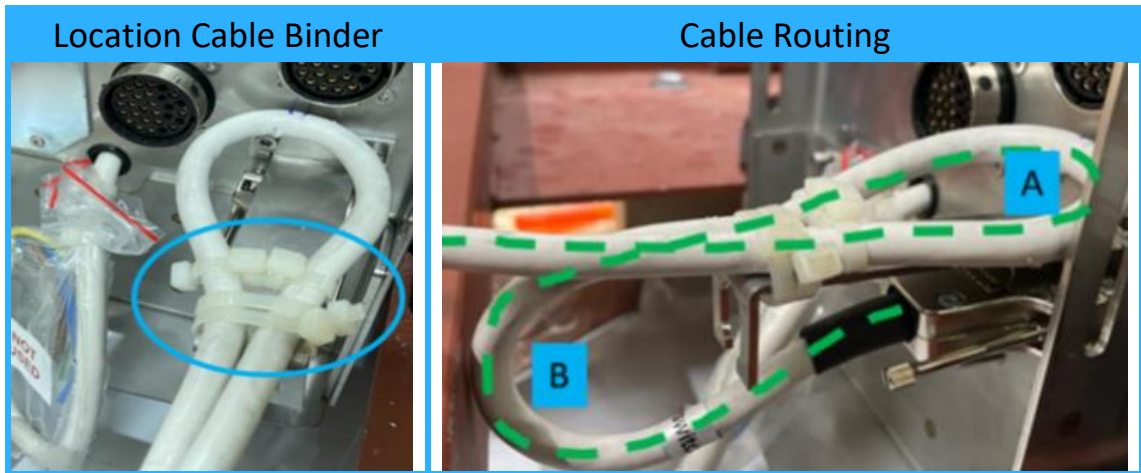
Figure 4b: AD7NT Patient Table with cable tie strain relief

Number of cable binder(s): 5 (five)

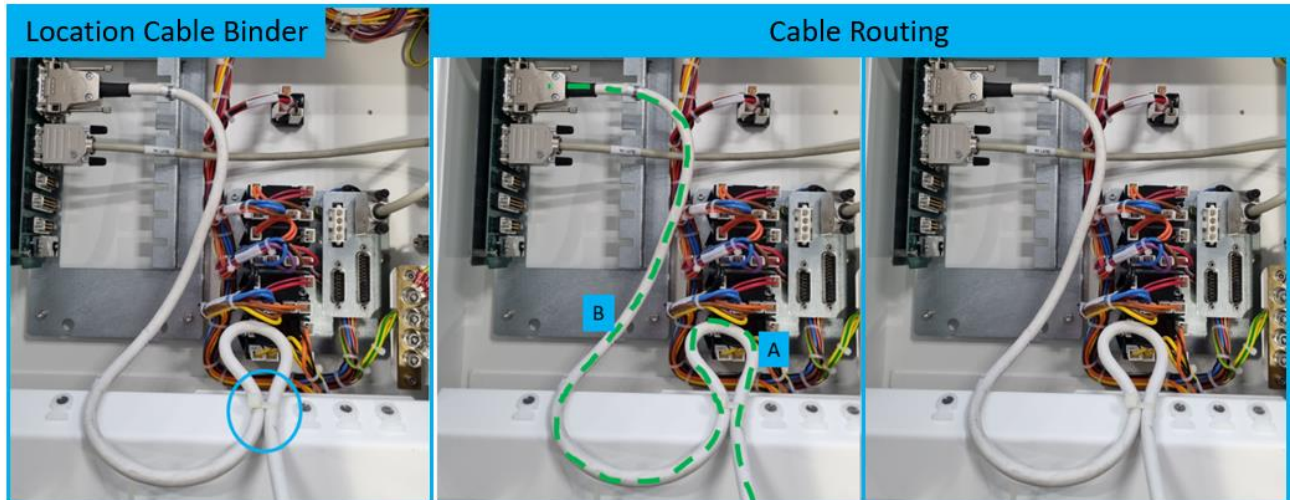
Figure 6: Surgery Wall Connection Box

Number of cable binder(s): 1 (one)

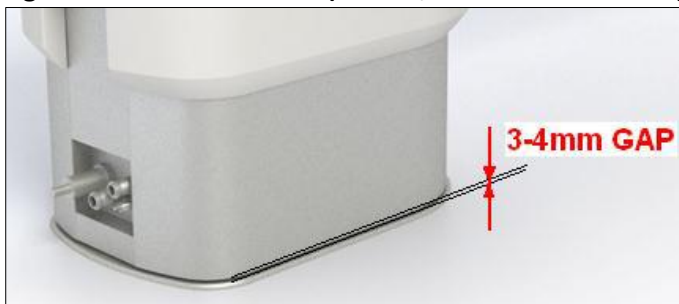
Figure 7: Non-swivel table (AD7NT, AD7XT and AD7XNT)

- For a non-swivel table
 - Make sure that the clearance to the fluid protection plate is 3-4 mm
 - Refer to Figure 7
- For a swivel table
 - Make sure that the clearance to the swivel cover is 3-4 mm
 - Refer to Figure 8

If the gap between the plinth covers and the floor does not satisfy the above requirement, adjust the plinth cover according to the repair instructions.
