URGENT Field Safety Notice

L-arm rotation cover may fall on Philips Allura and Philips Azurion systems with monoplane fixed ceiling mounts

31-Oct-2023

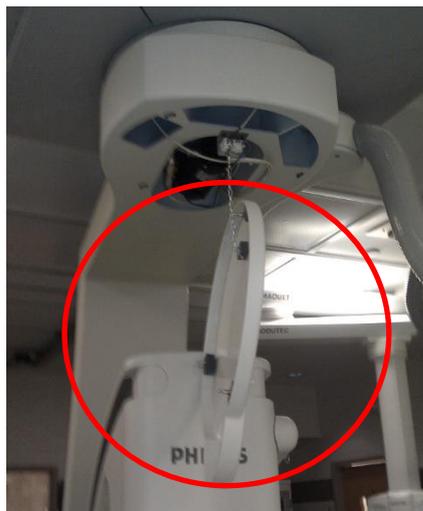
Philips has identified a potential safety issue with the Philips Allura and Azurion Product Families having monoplane fixed ceiling mounted systems. The ceiling mounted L-arm contains a rotation cover that may potentially be susceptible to falling if a collision between the L-arm and other hospital equipment (i.e., an operating light) were to occur. Although the cover is retained by a safety chain, if a collision were to occur the chain may also detach resulting in the cover falling on the patient, user, or bystander. There have been 5 incidents where minor injuries, such as bruises or scratches, were reported. To date, there have been no reported serious injuries or deaths related to this issue.

Figure 1: Example of a detached L-arm rotation cover

As a remedy, Philips is replacing the existing covers of all the affected Philips Allura and Philips Azurion with the monoplane fixed ceiling mounted systems with a redesigned L-arm rotation cover (bolted instead of spring clips) to make sure it is resistant to external collisions.

Philips will contact all affected customers to arrange for a Field Service Engineer visit to replace the L-arm rotation cover free of charge (reference FCO72200510 for the Philips Allura systems, including the Philips Poly G H5000, FCO72200511 for the Philips Azurion systems).

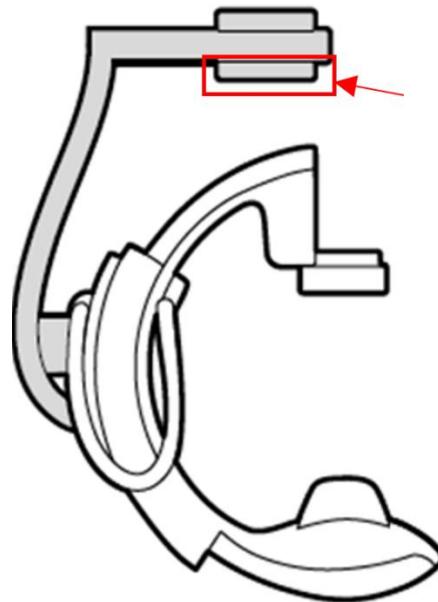
All Allura and Azurion Product Families with the monoplane fixed ceiling mounted systems are affected by this issue, as shown in Figure 2 and Table 1 below.

Figure 2: Only monoplane fixed ceiling mounted systems are impacted (as shown above)
