**URGENT Field Safety Notice**

**Panorama 1.0T HFO, All Serial Numbers**

Potential for serious injury resulting from structural integrity failure following a magnet quench

17-NOV-2023

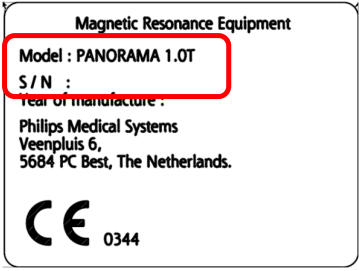
Figure 1. Example System Label	Product Name	Model

The affected Panorama 1.0T HFO systems including product number, name and serial number are listed in Appendix A. Figure 1 illustrates the location of the product name and serial number.
