**URGENT Field Safety Notice**

**BrightView, BrightView X, BrightView XCT**  
Patient Extremity Entrapment Hazard while using Pre-Programmed Motion

December 21, 2023

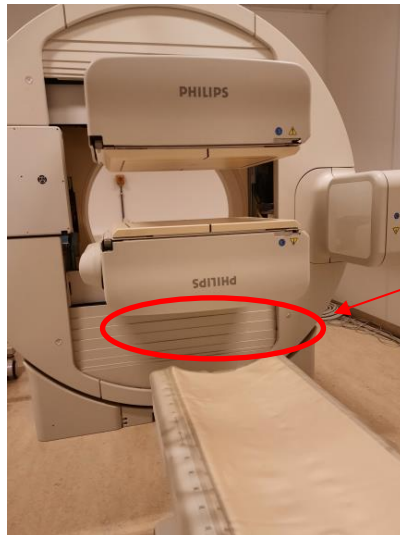
*Figure 1. Image of gap between the patient support and detector*

While using Pre-Programmed Motion (PPM) in a non-clinical or quality control manner, a gap can be created between the patient support and the detector, which presents a potential hazard. The gap can occur if the External QA PPM is executed and the lower detector is raised up and the patient table is lowered, both using the hand controller. This gap presents a potential extremity entrapment hazard for patients while the system detectors and patient support are in motion.

Gap between the detector and patient support. During PPM, the gap may decrease creating the potential for extremity entrapment.

Philips is working to provide a solution to remove this potential hazard identified with the use of the PPM. In the interim, initiate the "Patient Loading PPM" without the patient on the imaging table, prior to use and proceed in accordance with the guidance of the system warning as shown in Figure 4 and refer to the Instruction For Use guidance outlined below.

Philips will contact you to schedule a time for a Philips Field Service Engineer (FSE) to visit your site and install a technical solution to resolve this issue (refer to FCO88200537).

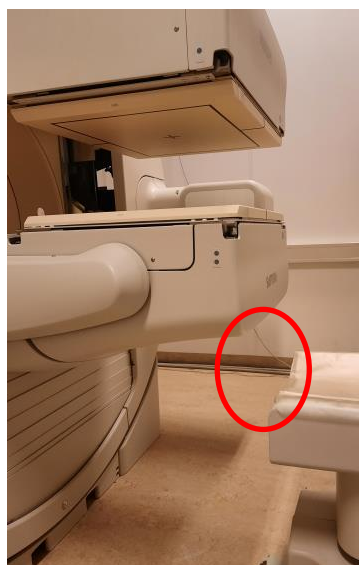
*Figure 2. Side Image of gap between the patient support and detector*

Philips has received one (1) report of an adverse event associated with this issue. In this reported event, the operator positioned a patient on the patient support and initiated the total body Pre-Programmed Motion (PPM). While the patient support and detectors were in motion, the patient straightened their leg due to a cramp, causing their foot to extend and become entrapped between the patient support and the detector. The patient sustained a foot fracture.

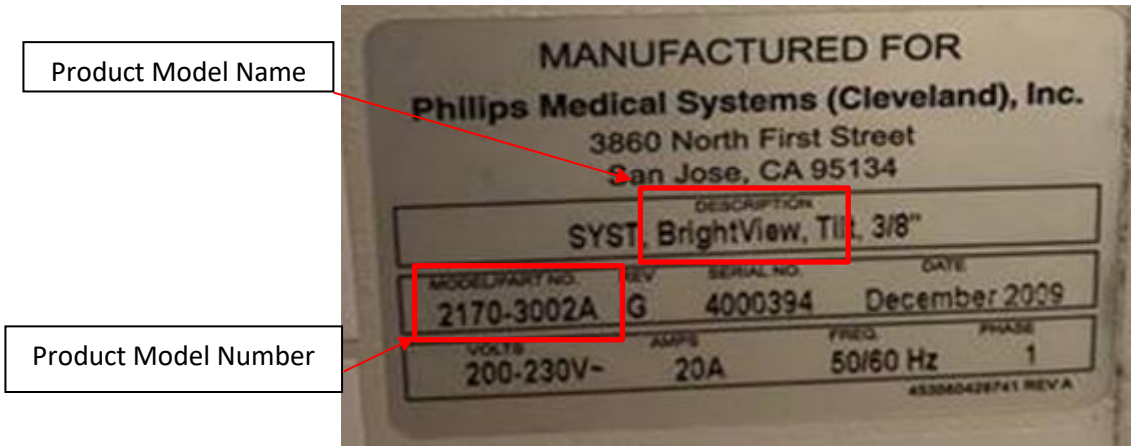
Figure 3. Equipment label

To locate the product model name and product model number, locate the equipment label on the back of the gantry near the bottom right as shown in Figure 3. Figure 3 is showing a sample label for

BrightView product model 2170-3002A (882480) as an example. Note: The system label may not have the same digit format as the example shown below.
