URGENT Field Safety Notice

Philips **Azurion System** R1.0, R1.1, R1.2, R2.0, R2.1, and R2.2
Potential loss of imaging functionality and clinical data stored in the system

08-DEC-2023

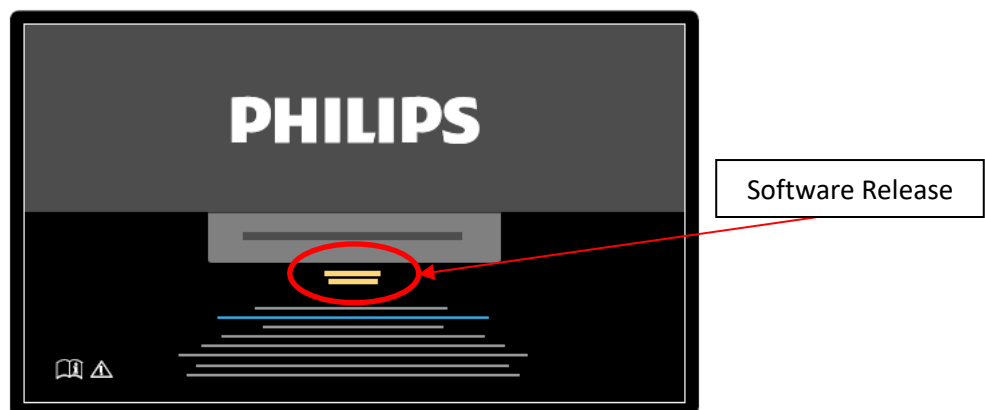
Figure 2: System start-up screen

The software version of the Philips Azurion system can be identified during start-up (Figure2).

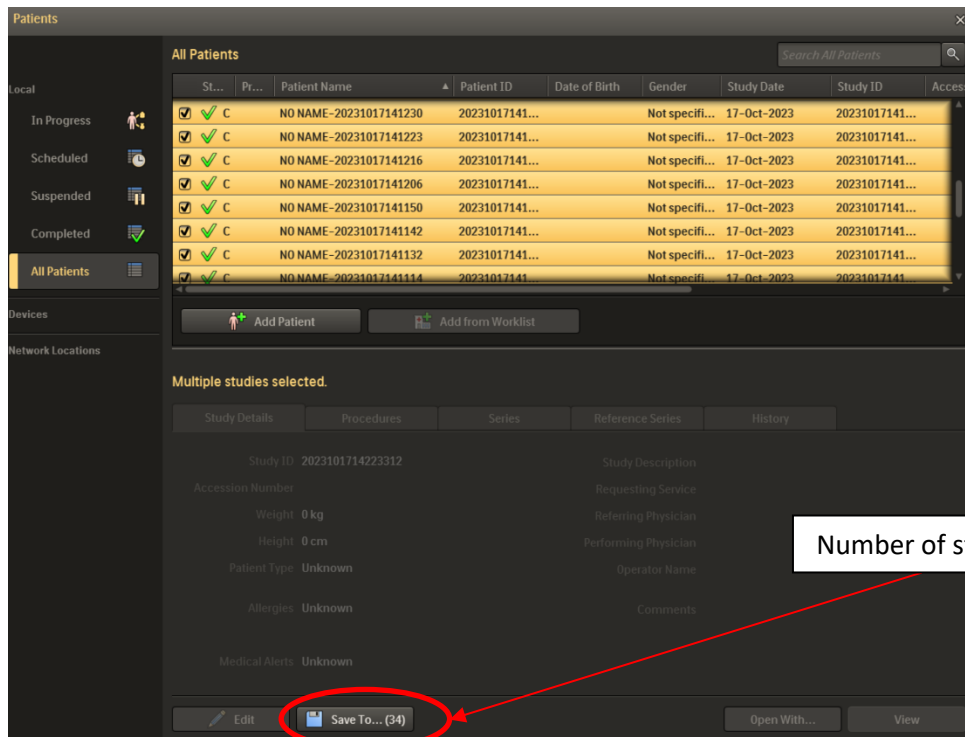
The number of studies can be determined by selecting all studies in the table (Ctrl+A). The number of studies is displayed at the lower part of the screen, see image below.

Note: There is no direct relation to the image disk space used. The number of studies can be high while the image disk is only partially filled, in case only a few images are saved for each patient.

- Keep this Urgent Field Safety Notice letter with the documentation of the system until Philips corrects your system. Ensure the letter is in a place likely to be seen/viewed.
- Keep the number of studies in the patient database as low as possible, but at least below 500.

- When deleting studies, ensure the studies are archived and delete the studies in small batches (<10).
- Circulate this notice to all users of the system so that they are aware of the issue.
- Return the attached response form (page 5) to Philips promptly and no later than 3 days from receipt to confirm that the users of the system have reviewed and understood this Field Safety Notice and required actions to be taken.
