URGENT Field Safety Notice

BrightView, BrightView X, BrightView XCT (Product Codes 882480, 882478, 882482)
Potential Detector Fall could Result in Injury to the Patient

December 14, 2023

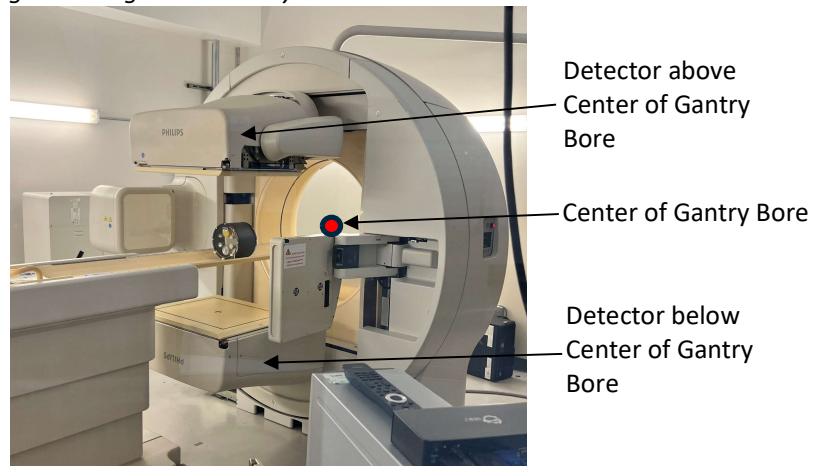
Figure 1. BrightView XCT system detector location

- **Scenario 1:** If the detector is below the center of the gantry bore and the detector support component fails, the detector may descend downward unexpectedly and potentially contact the patient.
- **Scenario 2:** If the detector is above the center of the gantry bore and the detector support component fails, the detector will not be able to move to complete the imaging.

Refer to Figure 1 for the location of detectors relative to the gantry bore.

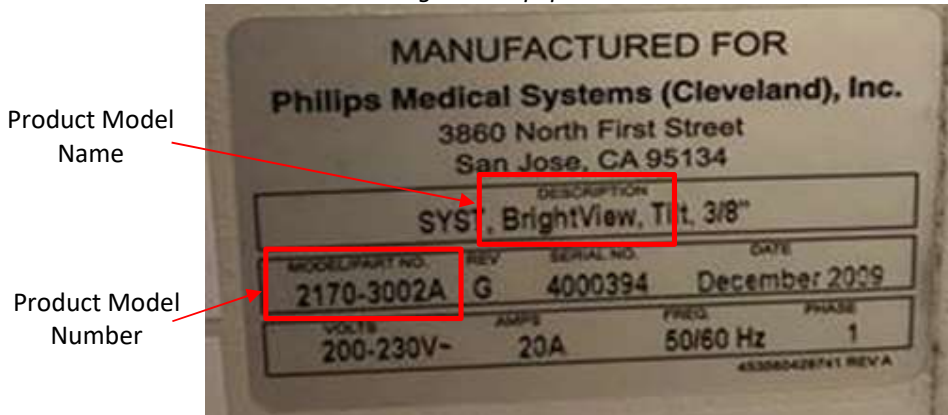
Figure 2. Equipment label

To locate the product model name and product model number, locate the equipment label on the back of the gantry near the bottom right as shown in Figure 2. Figure 2 shows a sample label for BrightView product model 2170-3002A (882480) as an example. Note: The system label may not have the same digit format as the example shown below.

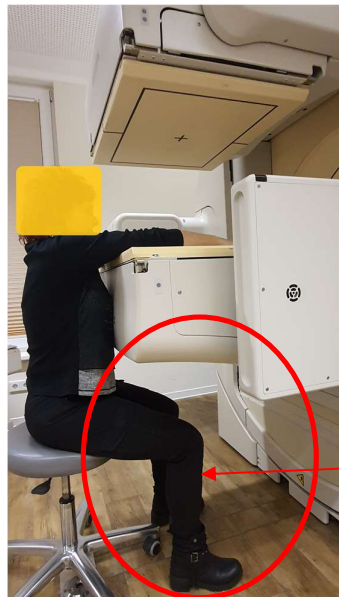
Figure 3. Avoid positioning a patient's lower limbs under the detector below Center of Gantry

Scenario 1, Detector positioned below center of gantry: If the patient’s lower limb(s) is directly below the lower detector and the support component fails, the detector may descend downward in an uncontrolled manner and contact the patient. There is a potential for abrasion, contusion, laceration, and/or fracture to the patient’s lower limb(s). Additionally, there will be an interruption to normal system operation. A rescan or re-injection of radiopharmaceutical to the patient may be required.

Do not position a patient's lower limbs under the lower detector

- **Do Not** position a patient's lower limbs directly under the detector below the Center of Gantry bore (refer to Figure 3), for example while performing dual head (DH) hand (left/right) procedure.

Philips will contact you to schedule a time for a Philips Field Service Engineer (FSE) to visit your site and to inspect and correct the system if necessary (FCO 88200538).
