URGENT FIELD SAFETY NOTICE

GE HealthCare Ref. # 79072

RE: **Double image artifact with IC9-RS intracavitary probes**

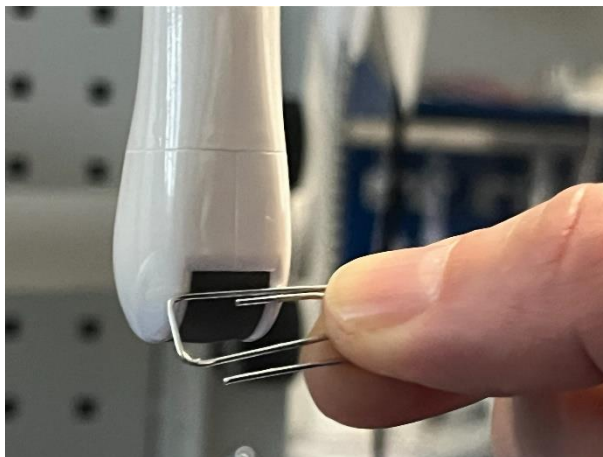
1. Run the edge of a smooth, metal reflector (paperclip, metal pen, flat side of tweezers or similar) along the probe lens starting at the edge of the field of view and running it along the full curvature of the probe (Figure 1).
2. The metal reflector will produce strong echoes localized at the point of contact.
3. To enhance the echoes, apply a smear of water on the metal reflector only.

Figure 1: Double image test procedure. Place metal reflector (paperclip shown) at the edge of the field of view. Run reflector along the full curvature of the transducer.

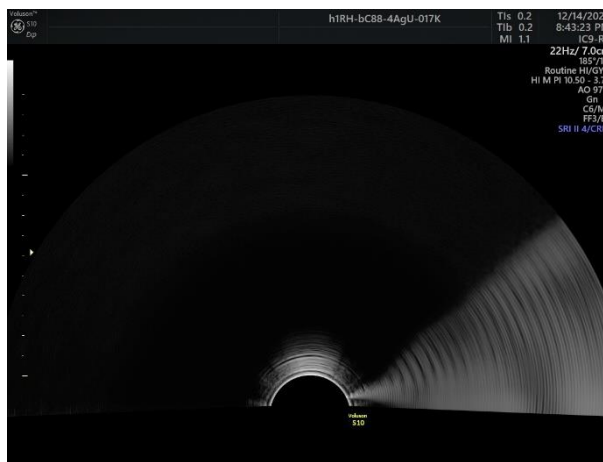
If an additional echo is seen in the sector opposite of the point of contact, the probe is producing a double image artifact. Double image artifacts are only visible towards the edges of the field of view. See test images below from a normal IC9-RS probe (Figure 2) and a malfunctioning IC9-RS probe producing double image artifact (Figure 3).

Figure 2. Test image from a normal IC9-RS probe. No artifact visible.

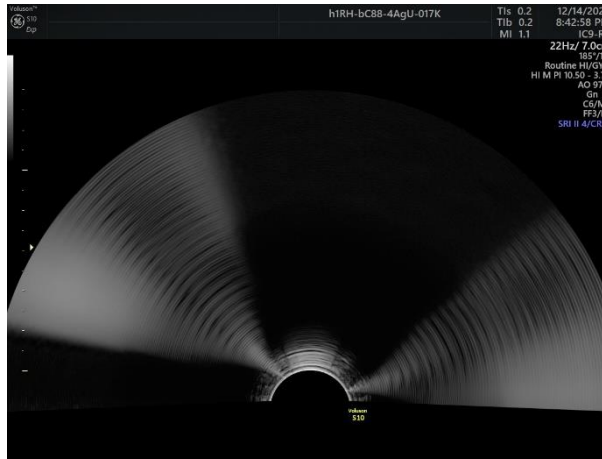
GE HealthCare has become aware of an issue with certain IC9-RS ultrasound probes (see Affected Products List) that can result in a double image artifact creating a ghost image with realistic features. An unrecognized artifact may lead to misdiagnosis.

Figure 3. Test image from a malfunctioning IC9-RS probe showing double image artifact in the opposite sector.

GE HealthCare will correct all affected products at no cost to you. A GE HealthCare representative will contact you about the correction method and schedule.

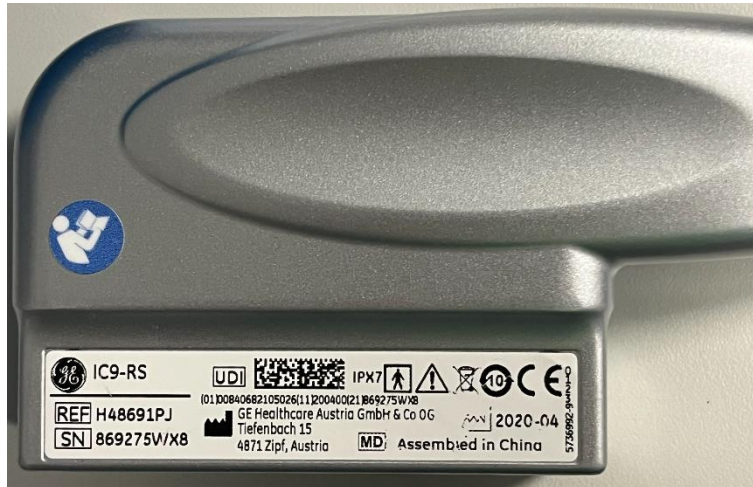
IC9-RS probes with a serial number included in Appendix A are affected by this issue. The serial number (SN) can be found on the rating plate as shown in Figure 4

Figure 4. Rating plate example – displaying probe type (IC9-RS) and serial number (SN).
