FSN Ref: PM6/SS13/FSN

Urgent field safety notice Easymoov6 enteral feeding pump Safety information

1. Information on the devices concerned*.		
1	1. Type(s) of device(s)*	
	Enteral feeding pump	
1	2. Trade name(s)	
	Easymoov6	
1	3. Unique device identifier(s) (UDI-DI)	
	<i>Reference</i>	<i>UDI-ID</i>
	0VEPM6	03660812096560
	0VEPM6A06	03660812096669
	0VEPM6C02	03660812096577
	0VEPM6C06	03660812096614
	0VEPM6C10	03660812099028
	0VEPM6C11	03660812144360
	0VEPM6D02	03660812106160
0VEPM6G02	03660812096553	
1	4. Primary clinical purpose of the device(s)*.	
	Enteral feeding	
1	5. Device model/catalog/parts number(s)*.	
	See reference 1.3	
1	6. Software version	
	All software versions	
1	7. Range of serial or batch numbers concerned	
	All serial numbers	
1	8. Associated devices	
	N/A

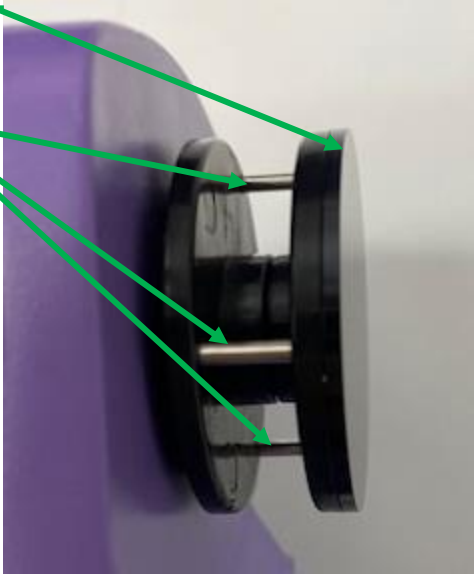
APPENDIX 1

2 Reason for safety corrective action in the field (FSCA)* (in French)	
2	1. Product problem description
	Medwin has been informed of an incident involving an Easymoov6 enteral nutrition pump. The pump's rotor no longer had the rollers required for rotary peristalsis, which can lead to significant overflow.
2 .	2. Risks behind the CASF
	Risk of serious digestive problems caused by a too fast feeding.
2	3. Probability of a problem occurring
	The problem may arise if the following steps occur chronologically: <ol style="list-style-type: none"> 1. The screw holding the two rotor flanges is unscrewed by a third party. 2. Both flanges are stressed and come loose, 3. The rollers are released from their housing and fall
2	4. Foreseeable risk for patients/users
	Overeating and severe digestive disorders, including vomiting.
2	5. Additional information to help characterize the problem
	N/A
2	6. Context of the question

Operating rotor	
<ul style="list-style-type: none"> Retaining screw tightened 3 rollers

Faulty rotor	
<ul style="list-style-type: none"> Loose retaining screw No rollers

3.	3. Type of action to mitigate risk*.	
3.	1. Measures to be taken by the user* <input checked="" type="checkbox"/> Identify the device <input type="checkbox"/> Quarantine the device <input type="checkbox"/> Return device <input type="checkbox"/> Destroy device <input checked="" type="checkbox"/> Modify/inspect device on site <input type="checkbox"/> Follow recommendations for patient management <input type="checkbox"/> Take note of modification/strengthening of instructions for use (IFU) <input type="checkbox"/> Other <input type="checkbox"/> None <ul style="list-style-type: none"> • Identify pumps whose rotor does not have the 3 rollers required for correct pump operation. (See pictures in annex) • Immediately repair the pump. Contact your local Vygon representative to arrange rotor replacement if necessary. • Make nursing staff aware of the problem, so that they check the rotor before feeding. • Remind staff that : <ul style="list-style-type: none"> - Any dismantling of the rotor, for cleaning purposes for example, must be carried out by a competent and trained member of the plant, - The use of the automatic purge function at each tubing change also reveals any occlusion defects in the rotor.

3.	4. Does the customer have to reply? * (If yes, form attached specifying deadline for return)	Yes
3.	5. Measures taken by the manufacturer <input type="checkbox"/> Product withdrawal <input type="checkbox"/> Modification/inspection of device on site <input type="checkbox"/> Software update <input type="checkbox"/> Modification of IFU or labeling <input checked="" type="checkbox"/> Other <input type="checkbox"/> None The rotor assembly method used in production has been modified to avoid separating the flanges and freeing the rollers.
