Field Safety Notice, Medical Device Correction #133261

RayStation RayPlan 7-2024A including some service packs

28th March, 2024

RSL-P-RS FSN Class III 133261

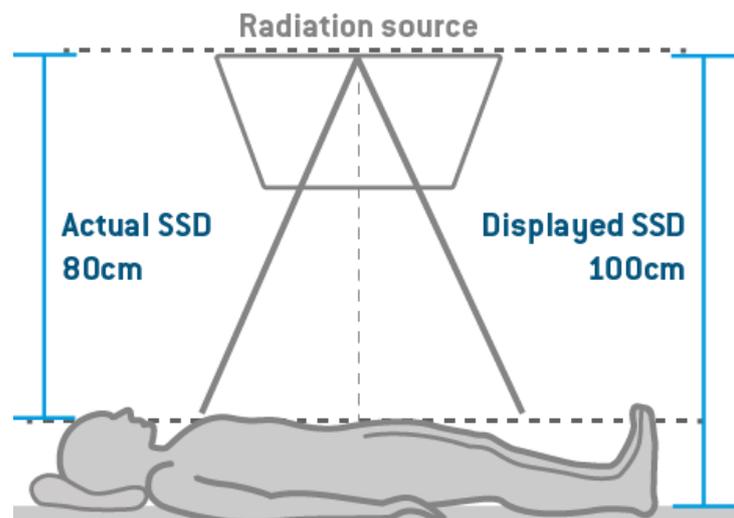
In very rare cases, the calculation algorithm for the reported SSD (i.e., the SSD displayed and exported) will miss the first ROI in the beam path and instead calculate the distance to the entry point of an ROI that lies further down in the beam path, resulting in an incorrectly reported SSD. If this occurs, the reported SSD will be incorrect in the GUI, in the plan report, in DICOM export and when accessed via scripting. Both treatment beams and setup beams may be affected. It is unlikely that all beams in a beam set are affected, since the issue will only be triggered under special circumstances of ROI geometry and beam angles. The SSD saved to a beam commissioning field to be used with arbitrary photon fields in RayPhysics can also be affected.

Dose calculation will not use the reported SSD which means that the calculated dose is correct and consistent with the plan. However, if the reported SSD is used for setting up the patient, the calculated dose will not match the delivered dose. The delivered dose will be overall lower than intended, but the irradiated volume will be larger.

The reported SSD should in this example be the distance from the radiation source to the beam entry point of the External ROI. If the bug occurs, the External ROI is not included in the calculation and the incorrect reported SSD is the distance from the radiation source to the beam entry point of the couch ROI which is the next ROI in the beam path.

- The intended SSD is 100 cm and the user enters 100 cm SSD.
- If the bug is triggered, the reported SSD will be 100 cm but it will be calculated as the distance to the couch ROI. In this example, it will be displayed as 100 cm in the beam list, but the plan isocenter is in reality placed so that the actual SSD (which is the distance to the entry point of the External ROI) is shorter than 100 cm, see Figure 1 below. In this example, the actual SSD in the plan is 80 cm. All displayed values are correct, except for the reported SSD value in the beam list.
- Dose is calculated based on the plan with SSD 80 cm.
- The reported SSD in the exported RT Plan/RT Ion Plan and the plan report is 100 cm.
- If the patient is treated at SSD 100 cm, the delivered dose will not match the dose that was calculated in RayStation/RayPlan.

Figure 1. The patient shown in relation to the radiation source. In this example, the reported SSD displayed in RayStation/RayPlan is 100 cm, whereas the actual SSD in the plan is 80 cm.

- If the reported SSD is to be used for patient setup or other critical tasks, use the Measure tool to measure the distance in the patient view to make sure that the reported SSD value is correct.
- If the reported SSD value is found to be incorrect, small changes to isocenter, beam angles or the affected ROI's geometry can be made until the correct value is achieved.
- Educate planning staff and all users about this workaround.
- Inspect your product and identify all installed units with the above software version number(s).
- **Confirm you have read and understood this notice by replying to the notification email.**

This issue will be resolved in the next version of RayStation/RayPlan, scheduled for market release in April 2024 (subject to market clearance in some markets). If customers wish to continue using versions of RayStation/RayPlan affected by this notice, all users must maintain awareness of this notice. Alternatively, customers can choose to upgrade to the new version once it becomes available for clinical use.
