URGENT Field Safety Notice

MR systems terminal connections in the general Mains Distribution Unit (g-MDU) may produce a Thermal Event

19-April-2024

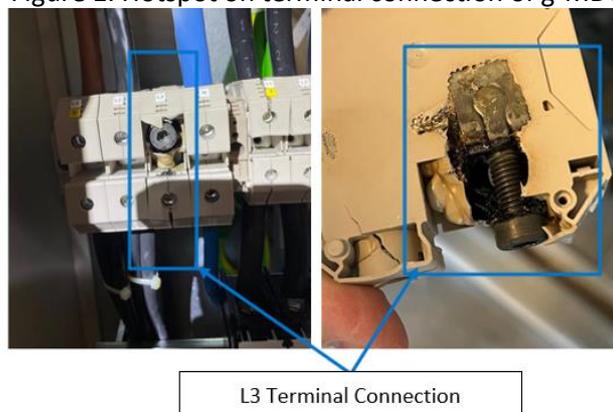
Philips has identified an issue where the g-MDU (global Mains Distribution Unit) L3 terminal connection may become loose creating a hotspot (see figure 1) that may cause smoke/fire to alarm in the hospital's technical room. The g-MDU, located in the technical room, is the single-entry point for the hospital electricity supply and distributes the electricity toward the various cabinets and components of the MR Scanner.

Figure 1. Hotspot on terminal connection of g-MDU

Philips has received five (5) complaints of burnt g-MDU terminal connections, and smoke /burning smell in the technical room associated with the issue. There was no report of injury or serious harm.

Philips will contact you to schedule time for a Field Service Engineer (FSE) to visit your site to inspect the g-MDU connections in the technical room and apply the proper torque to the connection if necessary. (reference FCO78100582). Philips plans to start implementing corrections in July 2024.
