## **URGENT Field Safety Notice**

### **Multiva 1.5T**

Gradient Coil component failure may act as a heat source with potential to produce smoke and/or fire.

Jun 26, 2026

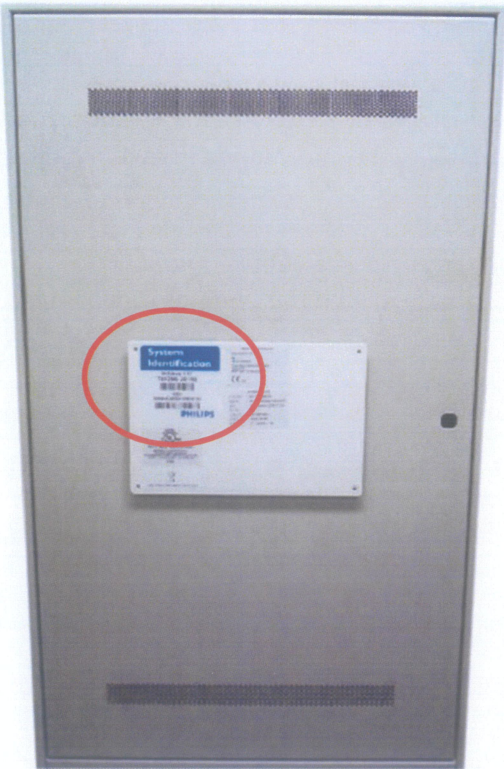
*Figure 1: Front door of gMDU*

- 3.1. Enter the Technical Room
- 3.2. Locate the general Mains Distribution Unit (gMDU) and Liquid cooling cabinet (LCC)
- 3.3. The system label is located on the front door of the gMDU (see figure 1) or LCC (see figure 2)
- 3.4. Locate the serial number on the system identification label (see figure 3)

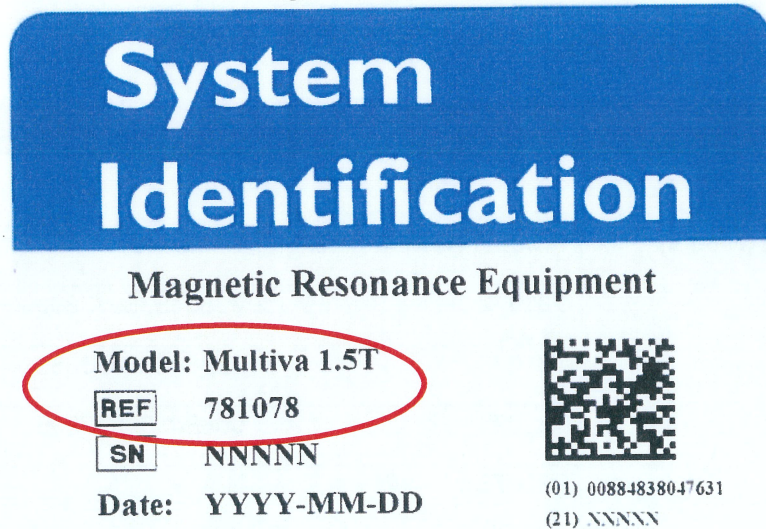
Figure 3: system label

The affected Multiva 1.5T MR Systems including product number (REF), name (Model) listed in below table. Figure 3 illustrates the location of the product number (REF) and name (Model) on the system label.

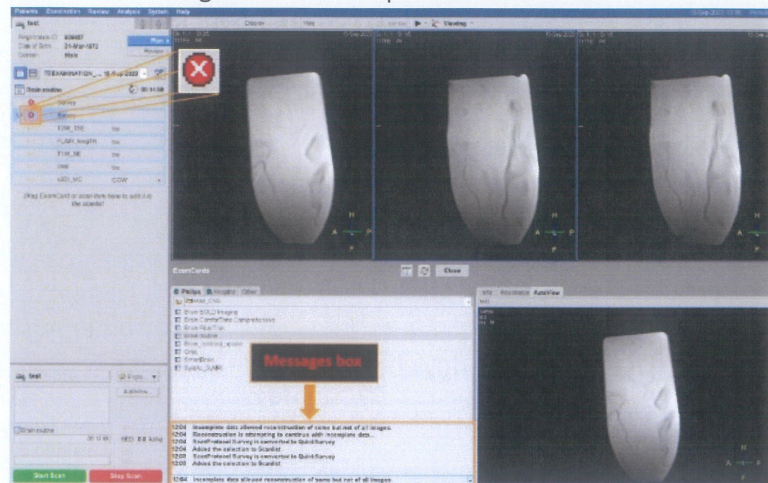
Figure 5. UI example SW Version R5.

- 4.3. When scan aborts occur the symbol is shown and applicable messages are presented in the message box (see Figure 5 example)
  - 4.3.1. Check the status of the error messages in the User Interface (UI) screen. Click to expand the message box in case previous messages are hidden, see orange box in Figure 5 below. If possible, correct the issue that is relevant to the error shown, and continue scanning, for example:
    - "RF door must be closed while performing scan. Scan aborted."
    - "Patient support is moved while scanning, scan stopped."
    - "Coil A (or B) failure, coil disconnected?"

- 4.3.2. If, after a scan abort, one of the following conditions occur five times in a row stop scanning immediately and contact Philips Service to describe the problem:

- If there is no error message in the message box
  - If the error message meaning is not clear
- 4.3.3. If the error message “Gradient amplifier Rack Fault” is received two times in a row, or if the error message “Gradient amplifier Rack Fault” is preceded or followed by an aborted scan with no message, then stop scanning immediately and contact Philips Service to describe the problem.

- 4.3.4. If you encounter any of these conditions described in 4.3.2 or 4.3.3 do not attempt any additional/further scans, including without limitation do not attempt any phantom scanning until your system has been checked and released by a Philips Service representative.

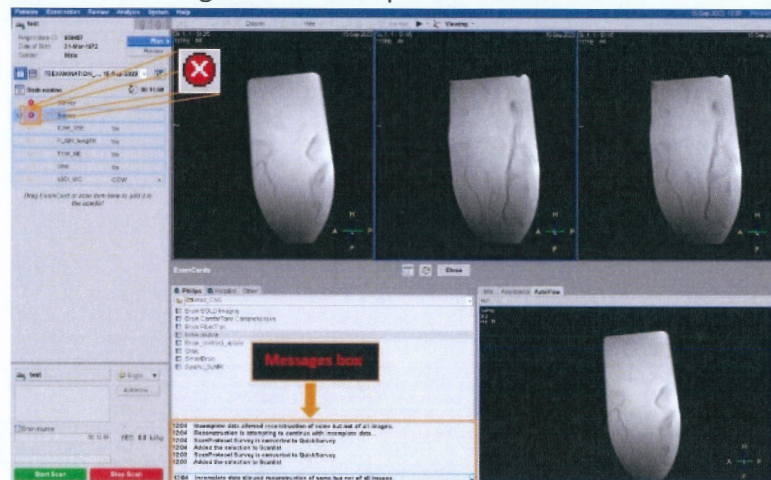
Figure 5. UI example SW Version R5.

- 4.3. When scan aborts occur the symbol is shown and applicable messages are presented in the message box (see Figure 5 example)
- 4.3.1. Check the status of the error messages in the User Interface (UI) screen. Click to expand the message box in case previous messages are hidden, see orange box in Figure 5 below. If possible, correct the issue that is relevant to the error shown and continue scanning, for example:
- “RF door must be closed while performing scan. Scan aborted.”
  - “Patient support is moved while scanning, scan stopped.”
  - “Coil A (or B) failure, coil disconnected?”.

- 4.3.2. If, after a scan abort, one of the following conditions occur five times in a row stop scanning immediately and contact Philips Service to describe the problem:
  - If there is no error message in the message box
  - If the error message meaning is not clear
- 4.3.3. If the error message “Gradient amplifier Rack Fault” is received two times in a row, or if the error message “Gradient amplifier Rack Fault” is preceded or followed by

an aborted scan with no message, then stop scanning immediately and contact Philips Service to describe the problem.

- 4.3.4. If you encounter any of these conditions described in 4.3.2 or 4.3.3 do not attempt any additional/further scans, including without limitation do not attempt any phantom scanning until your system has been checked and released by a Philips Service representative.
