URGENT Field Safety Notice

MR System Patient Support may experience restricted horizontal tabletop movement

23-Aug-2024

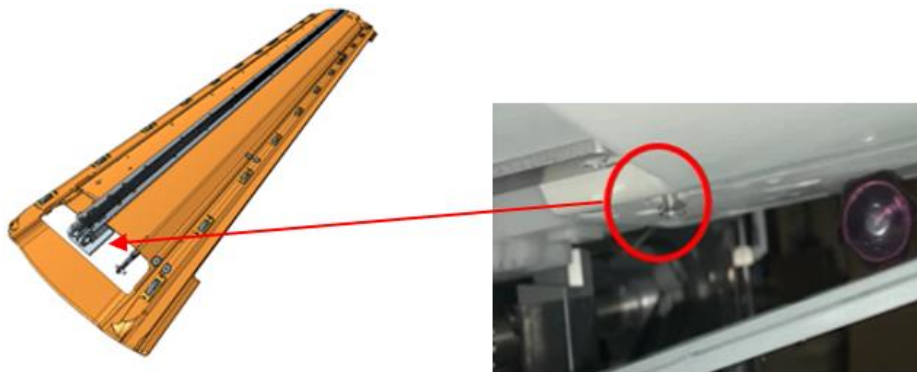
Philips has identified an issue in the MR System Patient Support where the Integrated Radio Frequency (IRF) Carrier assembly screws may come loose and protrude beyond the surface (Figure 1). This could cause the screws to interfere with other moving parts, potentially blocking the horizontal tabletop movement.

Figure 1. IRF Carrier protruding screws

If a tabletop movement blockage occurs, it could lead to delay in diagnosis and/or may include anxiety if a patient is left on the tabletop inside the bore for a longer duration than anticipated.

- C. If you experience resistance from the tabletop movement during patient scan, **Stop-use immediately** and contact your local Philips service representative.
- D. Circulate this Urgent Field Safety Notice to all users of this device so that they are aware of the issue.
- E. Please display attached 'Advisory' with your system(s); ensure the notice is in a place likely to be seen/viewed by operators.
- F. Please complete and return the attached response form to Philips promptly and no later than 30 days from receipt via email to: [<Market to insert contact information>](#). Completing this form confirms receipt of the Urgent Field Safety Notice, understanding of the issue, and required actions to be taken.

Philips will contact you to schedule time for a Field Service Engineer (FSE) to visit your site to inspect the IRF carrier assembly and provide a correction if necessary (reference FCO78100588). Philips plans to start implementing corrections in Q4 2024.

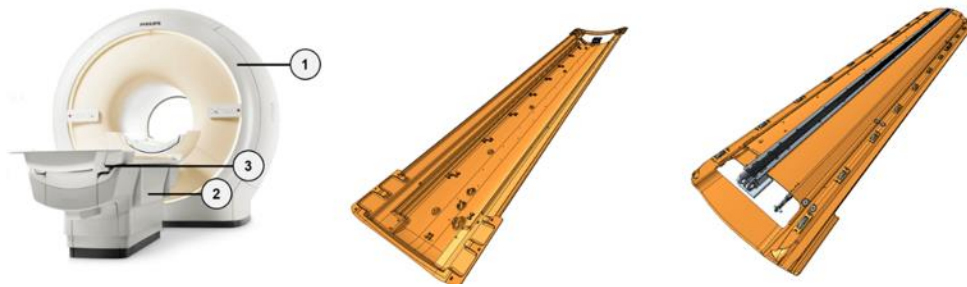
The IRF Carrier (Figure 2, Item 2 and 3), a component of the Patient Support within the MR system, supports the tabletop where the patient lies. As the patient moves into the MRI tunnel, the tabletop, supported by the IRF Carrier, forms a container for positioning the posterior coil.

Figure 2. MR System (left image: 1) MR Magnet; 2) Patient Support; 3) IRF Carrier) and IRF carrier (middle and right image).
