URGENT Field Safety Notice

Potential Loss of Electrical Grounding - IntelliVue Patient Monitor Power Supply

Reference: CR # 2024-CC-HPM-030, Potential Loss of Electrical Grounding - IntelliVue Patient Monitor Power Supply

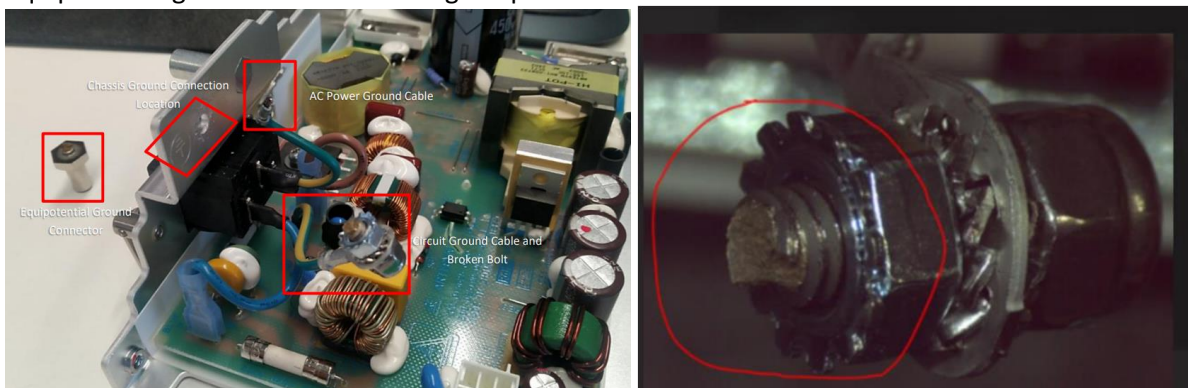
Electrical grounding is crucial to ensure that hospital patient monitoring equipment is safe, reliable, and in compliance with industry standards. Grounding provides a path for electrical current to return to the ground during faults, thereby minimizing risk of electric shock and protecting equipment from damage. It also controls leakage currents and dissipates static electricity that could pass through a patient’s body or impair device function. Additionally, grounding helps to reduce electromagnetic interference (EMI), ensuring accurate readings of patient vitals and reduction of interference with other electrical equipment in the healthcare environment. During a production process, Philips became aware of one IntelliVue power supply with a broken ground bolt upon disconnection of the ground cable from the equipotential ground connector. Image depicted below.

Figure 1. Power Supply Chassis and Circuit with Disconnected Ground Wires and Broken Ground Bolt

Loss of electrical grounding may negatively affect the device's electromagnetic immunity and emission. Degraded electromagnetic immunity can cause the monitor to generate unreadable or unusable waveforms, potentially leading to incorrect/delayed patient treatment. Excessive or unintended electromagnetic emissions can also negatively impact the function of equipment in the vicinity of the patient monitor, potentially leading to delayed procedure. Although unlikely, these scenarios could potentially result in patient harm.

- Please check if the equipotential connector is broken off (refer to Figure 1). If yes, remove the device from use.
- Pass this notice to all those who need to be aware within your organization or to any organization where affected devices have been potentially transferred.
- Please complete and return the response form at the end of this letter to Philips promptly upon receipt of this notice and no later than 30 days.

A Philips representative will contact you to schedule a visit from a Philips Field Service Engineer who will replace the power supply.
