## URGENT Field Safety Notice

### Multiva 1.5T

Gradient Coil component failure may act as a heat source with potential to produce smoke and/or fire.

October 23, 2023

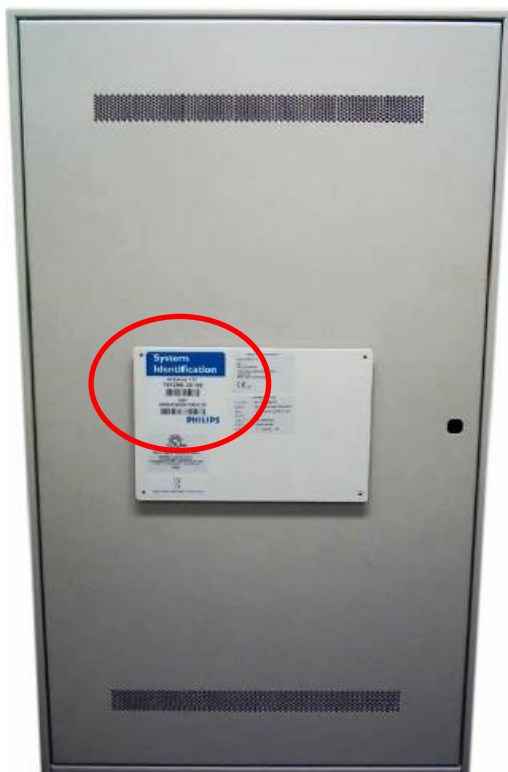
*Figure 2: Front door of gMDU*

- 3.1. Enter the Technical Room
- 3.2. Locate the general Mains Distribution Unit (gMDU) and Liquid cooling cabinet (LCC)
- 3.3. The system label is located on the front door of the gMDU (see figure 2) or LCC (see figure 3)
- 3.4. Locate the serial number on the system identification label (see figure 4)

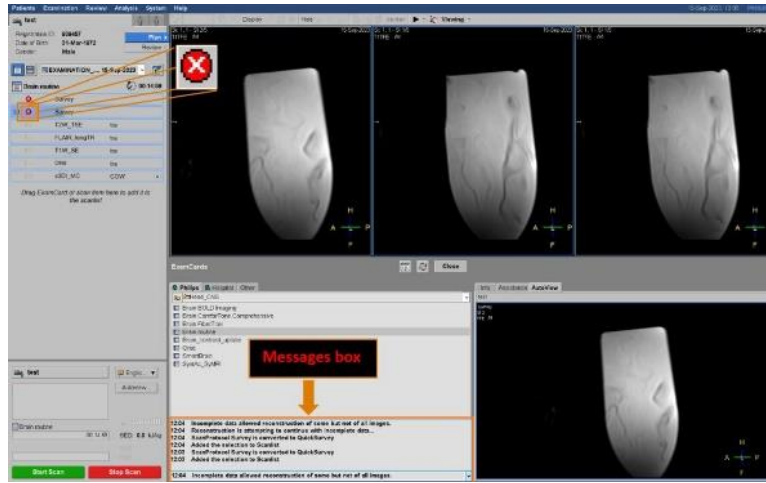
Figure 6. UI example SW Version R5.

- 4.3. When scan aborts occur the symbol is shown and applicable messages are presented in the message box (see Figure 6 examples)
  - 4.3.1. Check the status of the error messages in the User Interface (UI) screen. Click to expand the message box in case previous messages are hidden, see orange box in Figure 6 below. If possible, correct the issue that is relevant to the error shown, and continue scanning, for example:

- 4.3.2. If, after a scan abort, one of the following conditions occur five times in a row stop scanning immediately and contact Philips Service to describe the problem:
  - If there is no error message in the message box
  - If the error message meaning is not clear

- 4.3.3. If the error message “Gradient amplifier Rack Fault” is received two times in a row, or if the error message “Gradient amplifier Rack Fault” is preceded or followed by an aborted scan with no message, then stop scanning immediately and contact Philips Service to describe the problem.

- 4.3.4. If you encounter any of these conditions described in 4.3.2 or 4.3.3 do not attempt any additional/further scans, including without limitation do not attempt any phantom scanning until your system has been checked and released by a Philips Service representative.

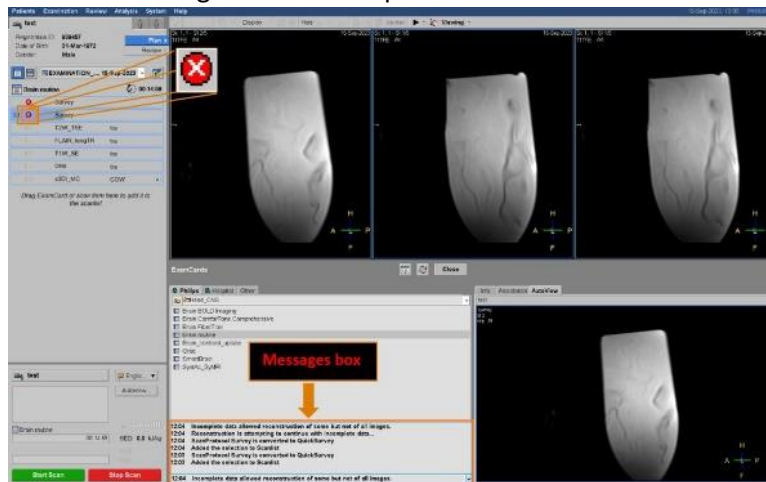
Figure 6. UI example SW Version R5.

- 4.3. When scan aborts occur the symbol is shown and applicable messages are presented in the message box (see Figure 6 examples)
  - 4.3.1. Check the status of the error messages in the User Interface (UI) screen. Click to expand the message box in case previous messages are hidden, see orange box in Figure 6 below. If possible, correct the issue that is relevant to the error shown and continue scanning, for example:
    - “RF door must be closed while performing scan. Scan aborted.”
    - “Patient support is moved while scanning, scan stopped.”
    - “Coil A (or B) failure, coil disconnected?”

- 4.3.2. If, after a scan abort, one of the following conditions occur five times in a row stop scanning immediately and contact Philips Service to describe the problem:
  - If there is no error message in the message box
  - If the error message meaning is not clear
- 4.3.3. If the error message “Gradient amplifier Rack Fault” is received two times in a row, or if the error message “Gradient amplifier Rack Fault” is preceded or followed by an aborted scan with no message, then stop scanning immediately and contact Philips Service to describe the problem.

- 4.3.4. If you encounter any of these conditions described in 4.3.2 or 4.3.3 do not attempt any additional/further scans, including without limitation do not attempt any phantom scanning until your system has been checked and released by a Philips Service representative.
