URGENT FIELD SAFETY NOTICE

Subject: Incorrect handling of non-square Image pixel spacing in Enterprise Imaging XERO Viewer at initial load leads to incorrect placement of reference lines.

- Enterprise Imaging XERO Viewer (UDI-DI: 05400874000710)

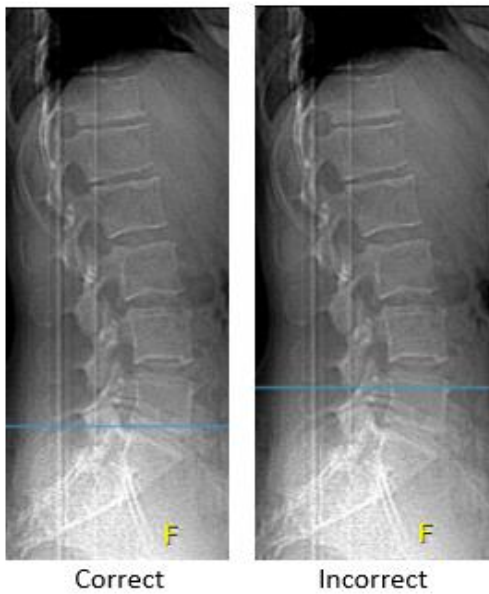
When an image has non-square pixel spacing, the reference/localizer line is incorrectly placed on the scout image in the XERO Viewer (offset from actual position). For example, when viewing a CT localizer radiograph, also known as a scanogram or scout image in the sagittal plane next to an axial series, the localizer/scout line or the active target localization tool may display the incorrect crosshair/line position on the non-coplanar/scout image with respect to the axial slice location.

Example of reference line placement difference in an affected study

Figure 1: Example of placement difference due to incorrect initialization in XERO Viewer

- Use the XERO Viewer Extended Tools component (Xtend), if enabled.
- Use the Enterprise Imaging Desktops viewer
- Scroll through other available scout/non-coplanar images in a series, or replace the current image in the display area with another series in order to correct any potentially misplaced scout line.

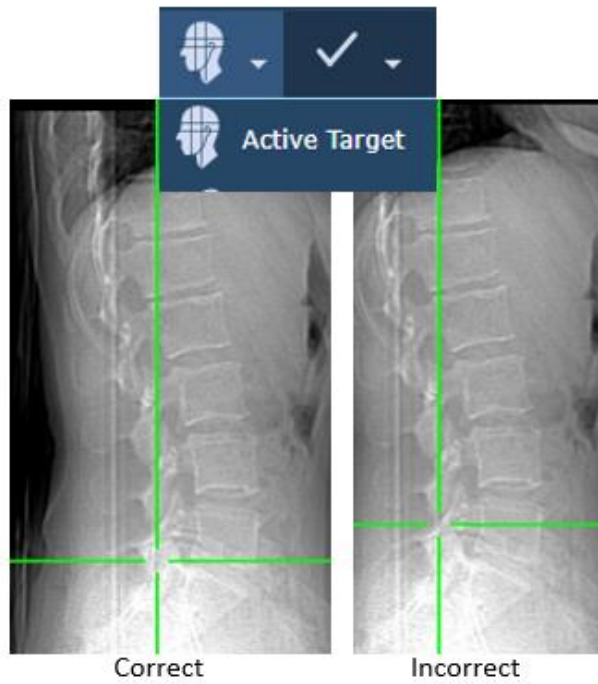
Example of Active Target placement difference in an affected study
