URGENT Field Safety Notice

Philips Azurion, Allura Xper, Integris and MultiDiagnost Eleva
Potential Detachment of the Cable Hose Carrier which May Result in Parts Falling and/or Part of the
Cable Hose Dropping

22-AUG-2024

Reference: 2023-IGT-BST-006: Philips Azurion, Allura Xper, Integris and MultiDiagnost Eleva;
Potential Detachment of the Cable Hose Carrier which May Result in Parts Falling and/or Part of the
Cable Hose Dropping

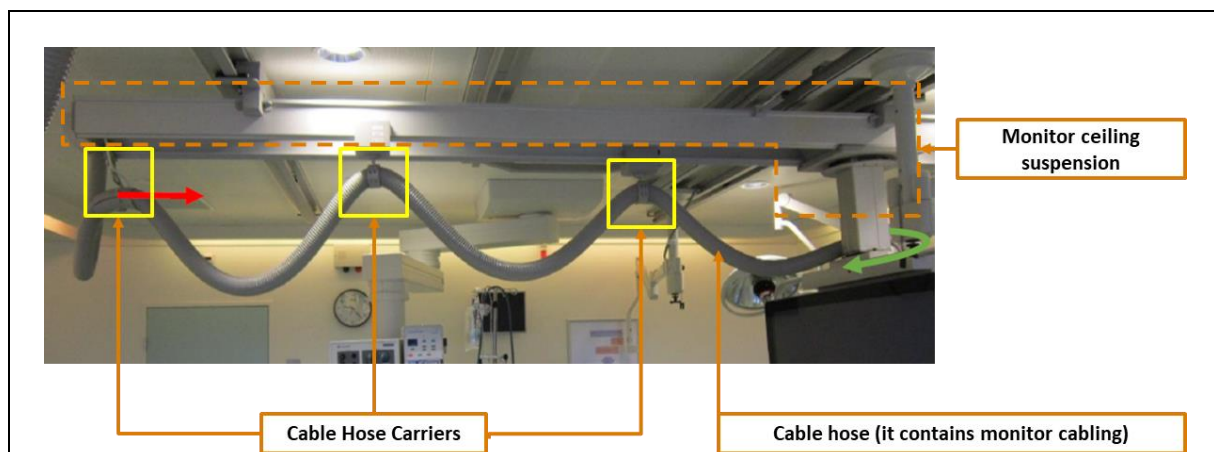
Philips has identified that due to the forces applied when moving or turning the monitor of the system, the bolts and plastic parts of the Cable Hose Carriers that hold the cable hose to the monitor ceiling suspension may become loose and/or break (see Figure 1). If this issue occurs, plastic parts and/or metal bolts of the Cable Hose Carrier(s) may fall and/or part of the cable hose may drop following the detachment of a Cable Hose Carrier.

Figure 1: When the monitor is moved or turned (green arrow), the cable hose pulls the Cable Hose Carriers and applies forces to their joint and bolted connections (yellow box).

Philips is redesigning the Cable Hose Carriers. Once the redesigned cable hose carriers are available, Philips will contact you to schedule a visit to install them in the affected system(s) (reference FCO72200536, FCO72200576, and FCO72200577). As of the date of this urgent Field Safety Notice letter, Philips expects the solution to be available by Q3 2025.

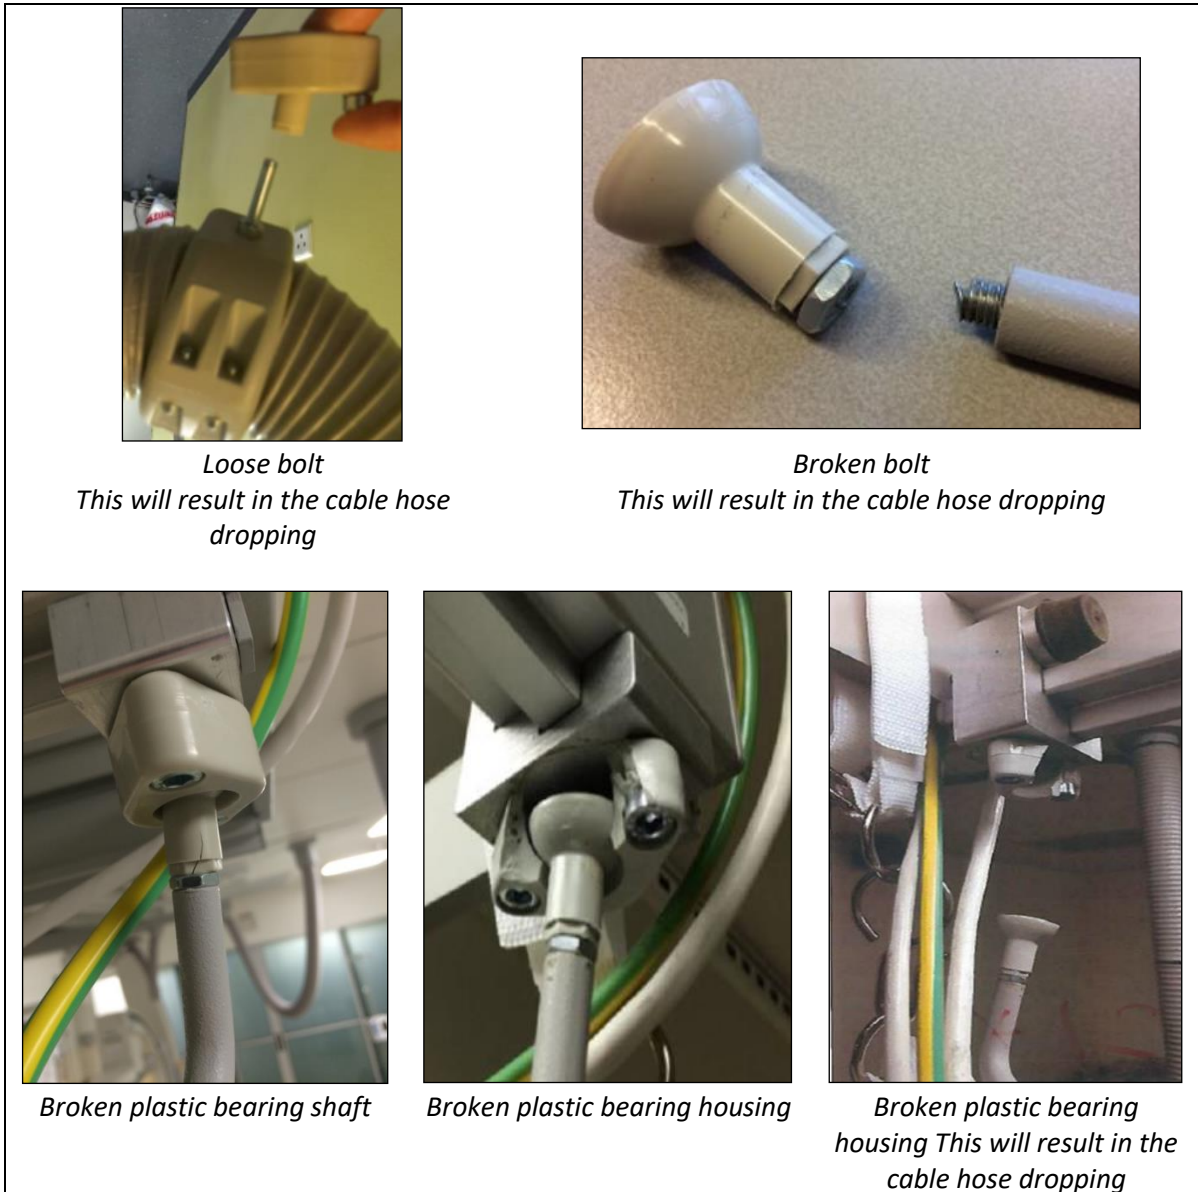
Figure 2: Examples of loose and broken bolts and plastic parts

Falling cable carrier parts and/or a drop of the cable hose may result in harm to an operator or a bystander in the vicinity (e.g., bruises/contusions, lacerations, pain, head injury, muscle/tendon damage, and neck stiffness). No serious adverse health consequences are reasonably expected.

- c. Avoid having the patient located underneath the Cable Hose Carriers (e.g., during transport).
- d. If you notice loose or broken bolts and/or broken plastic parts of the Cable Hose Carriers (see Figure 2), please contact your local Philips representative immediately.

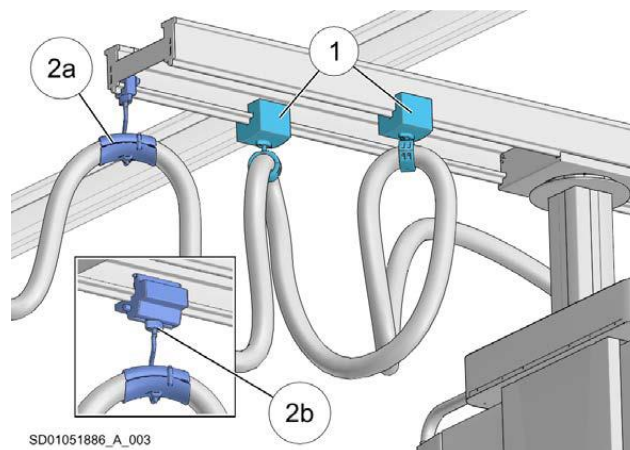
Fig. 01: Movable hose carriers (1+2b) and fixed hose carriers (2a)

1. Identify the cable hose carriers.
2. Make sure the movable cable hose carriers run smoothly.
3. Make sure the bolts and nuts of the cable hose carriers are fixed properly.

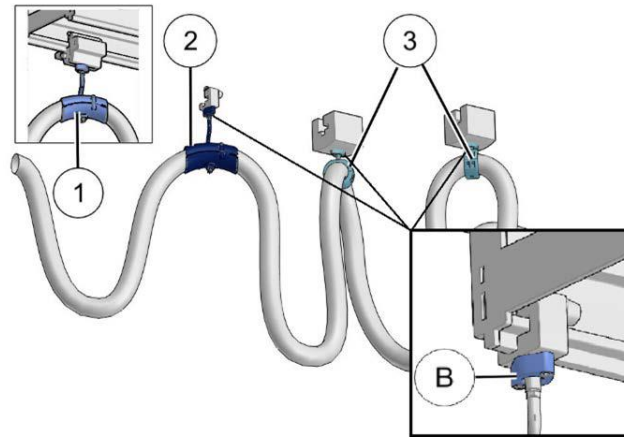
Fig. 02: The mounting base of the hose carriers

4. Examine the attachment and condition of the mounting base (B)
 - If there is any damage to the mounting base (for example cracks or broken parts), replace the mounting base.

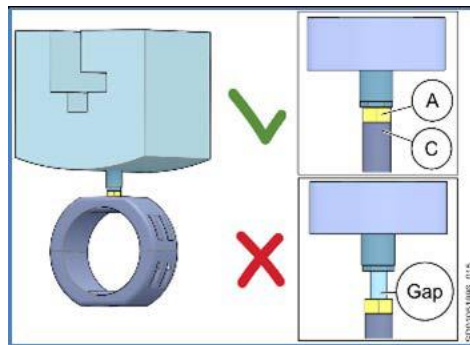
Fig. 03: Correct 'V' and incorrect 'X' ring carrier suspension

5. Make sure that all the nuts are tightened.
6. See if there is a visible gap.

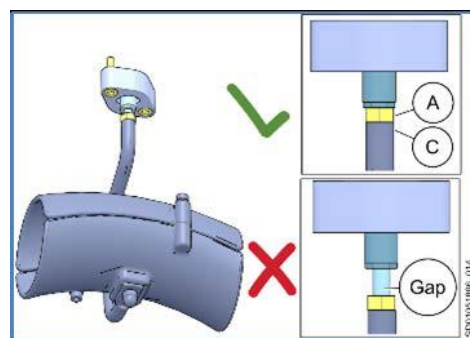
Fig. 04: Correct 'V' and incorrect 'X' banana carrier suspension

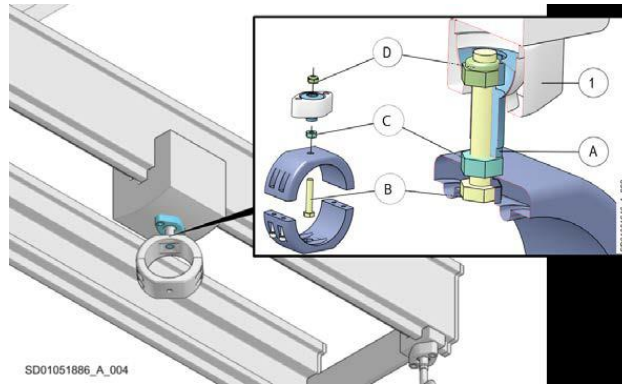
Fig. 05: Cable hose carrier with ring

7. If there is a visible gap for a carrier with ring:

- Loosen base (1) (2x M6).
- Loosen the plastic arm carrier (A) with nut (D).
- Loosen nut (C).
- Apply Loctite 243 to the thread of the bolt (B).
- Assemble the hose ring with bolt (B) and nut (C).

- Hold the nut (C) in position, then rotate and tighten the plastic arm carrier (A) with nut (D) until there is no gap.
