## Update – Field Safety Notice

### Multiva 1.5T

Gradient Coil component failure may act as a heat source with potential to produce smoke and/or fire.

## **URGENT Field Safety Notice**

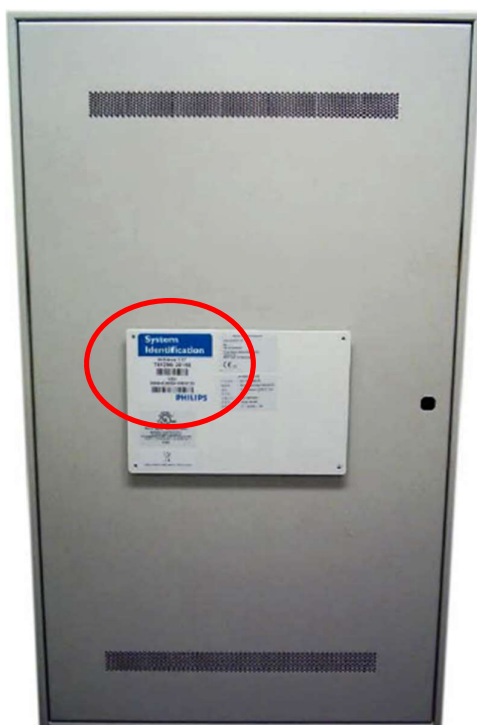
*Figure 1: Front door of gMDU*

- 3.1. Enter the Technical Room
- 3.2. Locate the general Mains Distribution Unit (gMDU) and Liquid cooling cabinet (LCC)
- 3.3. The system label is located on the front door of the gMDU (see figure 1) or LCC (see figure 2)
- 3.4. Locate the serial number on the system identification label (see figure 3)

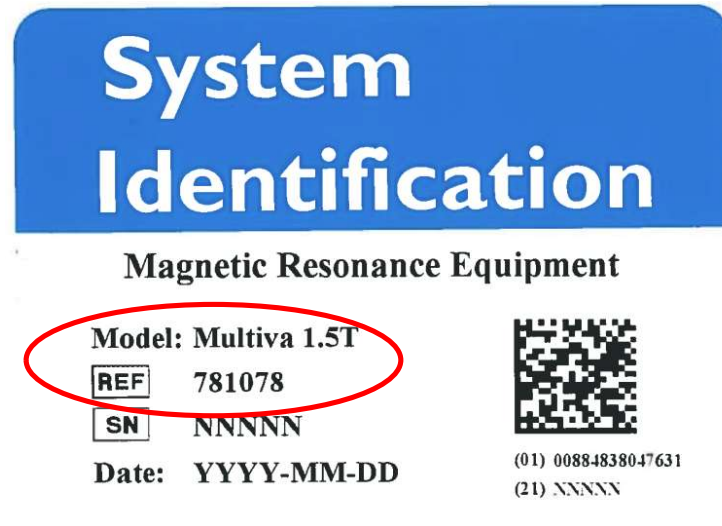
Figure 3: system label

The affected Multiva 1.5T MR Systems including product number (REF), name (Model) listed in below table. Figure 3 illustrates the location of the product number (REF) and name (Model) on the system label.

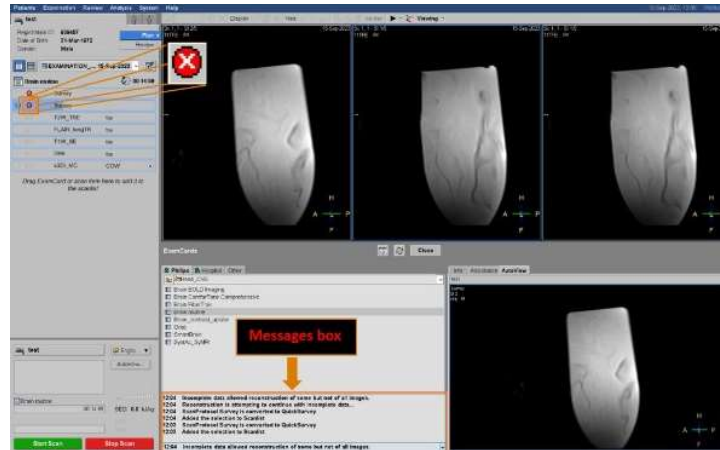
Figure 5. UI example SW Version R5.

- 4.3. When scan aborts occur the symbol is shown and applicable messages are presented in the message box (see Figure 5 example)
  - 4.3.1. Check the status of the error messages in the User Interface (UI) screen. Click to expand the message box in case previous messages are hidden, see orange box in Figure 5 below. If possible, correct the issue that is relevant to the error shown, and continue scanning, for example:
    - "RF door must be closed while performing scan. Scan aborted."
    - "Patient support is moved while scanning, scan stopped."
    - "Coil A (or B) failure, coil disconnected?".

- 4.3.2. If, after a scan abort, one of the following conditions occur five times in a row stop scanning immediately and contact Philips Service to describe the problem:

- If there is no error message in the message box
        - If the error message meaning is not clear
      - 4.3.3. If the error message “Gradient amplifier Rack Fault” is received two times in a row, or if the error message “Gradient amplifier Rack Fault” is preceded or followed by an aborted scan with no message, then stop scanning immediately and contact Philips Service to describe the problem.

- 4.3.4. If you encounter any of these conditions described in 4.3.2 or 4.3.3 do not attempt any additional/further scans, including without limitation do not attempt any phantom scanning until your system has been checked and released by a Philips Service representative.

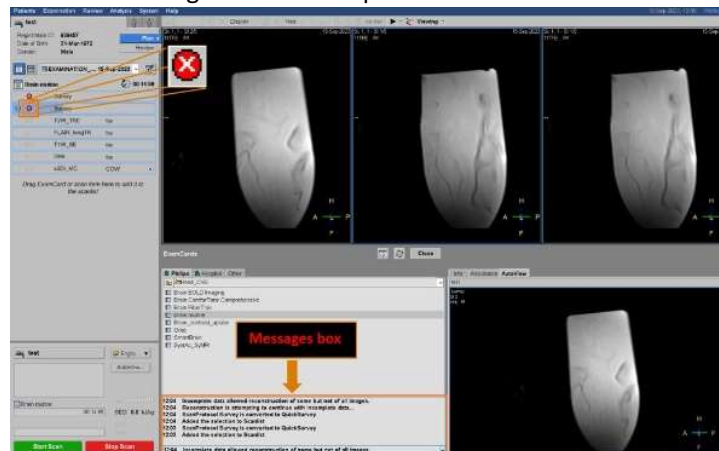
Figure 5. UI example SW Version R5.

- 4.3. When scan aborts occur the symbol is shown and applicable messages are presented in the message box (see Figure 5 example)
- 4.3.1. Check the status of the error messages in the User Interface (UI) screen. Click to expand the message box in case previous messages are hidden, see orange box in Figure 5 below. If possible, correct the issue that is relevant to the error shown and continue scanning, for example:
  - “RF door must be closed while performing scan. Scan aborted.”
  - “Patient support is moved while scanning, scan stopped.”
  - “Coil A (or B) failure, coil disconnected?”.

- 4.3.2. If, after a scan abort, one of the following conditions occur five times in a row stop scanning immediately and contact Philips Service to describe the problem:
  - If there is no error message in the message box
  - If the error message meaning is not clear
- 4.3.3. If the error message “Gradient amplifier Rack Fault” is received two times in a row, or if the error message “Gradient amplifier Rack Fault” is preceded or followed by

an aborted scan with no message, then stop scanning immediately and contact Philips Service to describe the problem.

- 4.3.4. If you encounter any of these conditions described in 4.3.2 or 4.3.3 do not attempt any additional/further scans, including without limitation do not attempt any phantom scanning until your system has been checked and released by a Philips Service representative.
