URGENT Field Safety Notice

Trilogy Evo, Trilogy Evo O2, Trilogy EV300
Flow Sensor Nebulized Aerosol Deposition

Reference: Flow Sensor Nebulized Aerosol Deposition
Trilogy Evo, Trilogy Evo O2, and Trilogy EV300
2024-CC-SRC-013

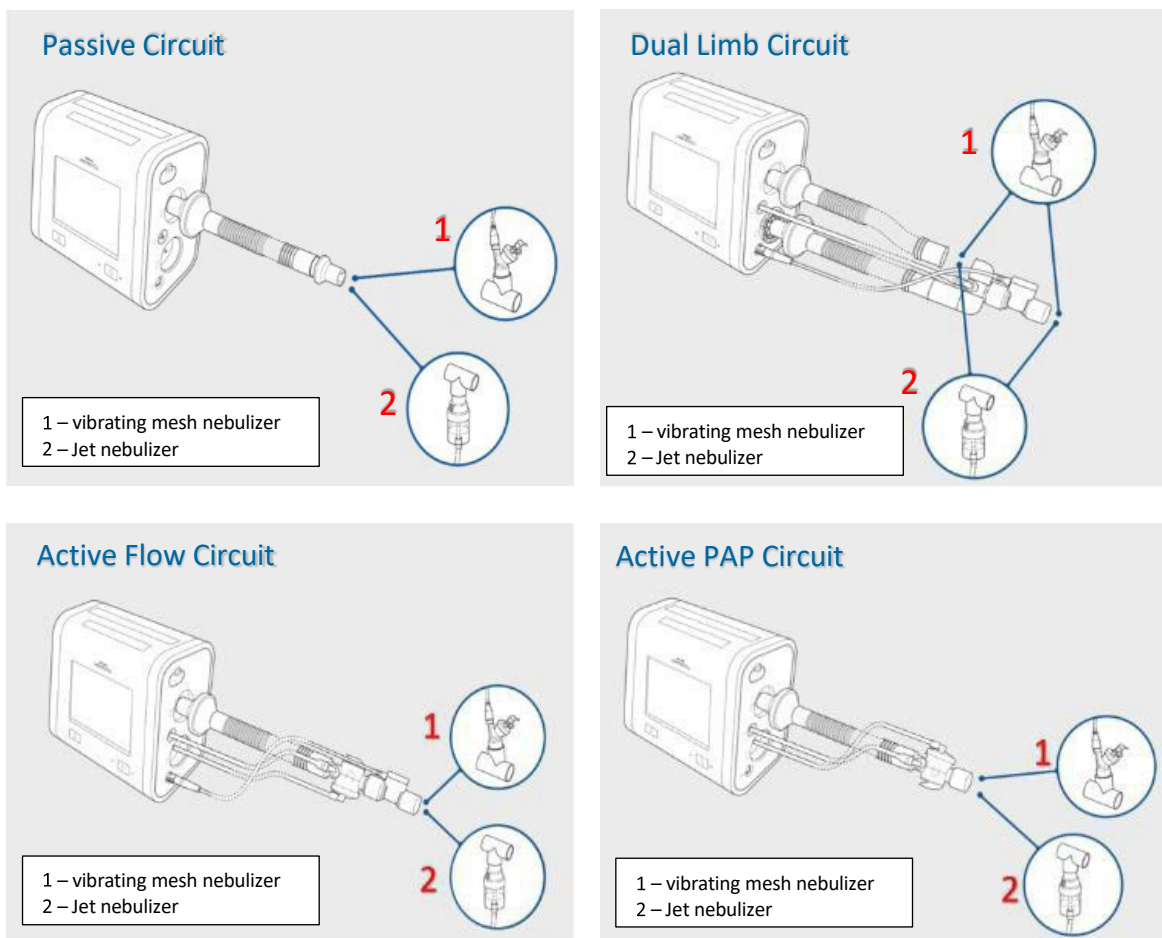
Figure 1: Acceptable In-Line Nebulizer Placement.

- When the in-line nebulizer is used with passive circuits for tidal volumes greater than or equal to 700 mL, or
- When the in-line nebulizer is placed at the dry side of the heated humidifier, or
- When the in-line nebulizer is placed at the “inspiratory port (to patient)” (device outlet), or
- When the in-line nebulizer is placed in any location *other than* those identified in the images in Section 4

- If using in-line nebulizer treatments:
 - The circuit must be configured as pictured in the images in **Figure 1** below
 - For prescriptions needing tidal volumes greater than 700 mL with a passive circuit, transition patient to alternate circuit (Active PAP, Active Flow, or Dual Limb).
