UPDATED: URGENT Field Safety Notice

Trilogy Evo, Trilogy Evo O2, Trilogy EV300
Flow Sensor Nebulized Aerosol Deposition

21-NOV-2024

Reference: Flow Sensor Nebulized Aerosol Deposition
Trilogy Evo, Trilogy Evo O2, and Trilogy EV300
2024-CC-SRC-013

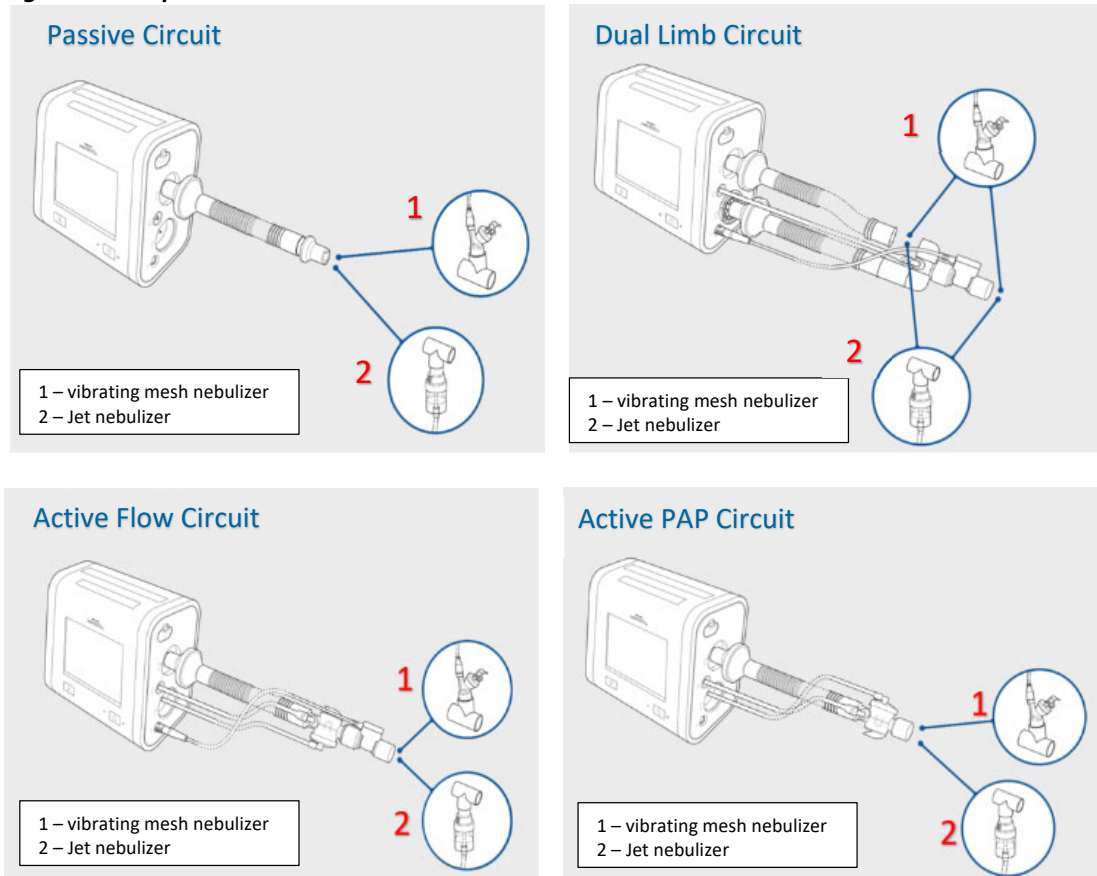
Figure 1: Acceptable In-Line Nebulizer Placement

- **If using in-line nebulizer treatments:**
 - The circuit must be configured as pictured in the images in **Figure 1** below.
 - For prescriptions needing tidal volumes greater than 700 mL with a passive circuit, transition patient to alternate circuit (Active PAP, Active Flow, or Dual Limb).

- When tidal volumes greater than 700 mL are used with a passive circuit, nebulized aerosol deposition can occur even if the nebulizer is placed as pictured.

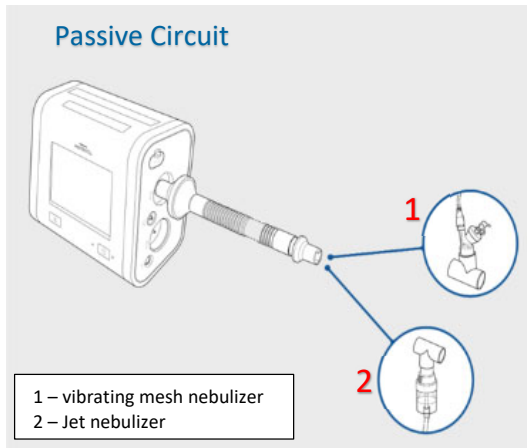
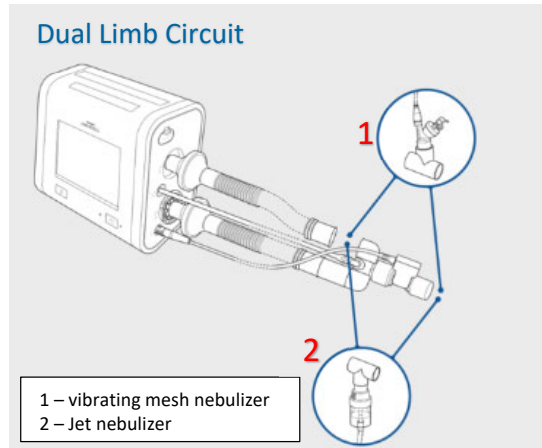
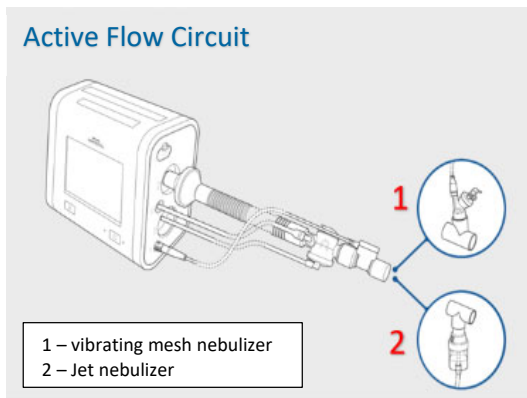
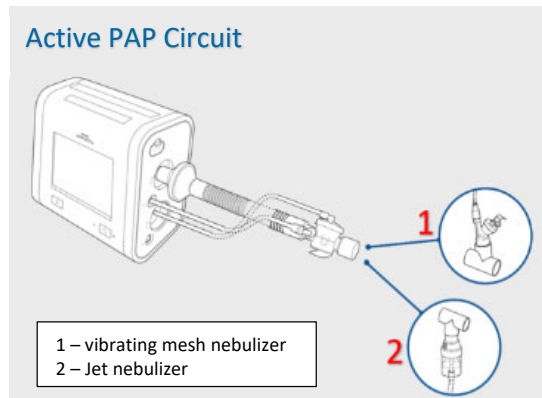
Appropriate Circuit Configurations for Use With In-Line Nebulizers

If using in-line nebulizer treatments, ensure the circuit is configured as shown in the images below.

- When tidal volumes greater than 700 mL are used with a passive circuit, nebulized aerosol deposition can occur even if the nebulizer is placed as pictured.

Note: For prescriptions needing tidal volumes greater than 700 mL with a passive circuit, transition patient to alternate circuit (Active PAP, Active Flow, or Dual Limb).
