Urgent Field Safety Notice

MiniCap Extended Life PD transfer

FA Number: FAV-2024-005

Manufacturer: Baxter Healthcare SA (CH-MF-000026124)

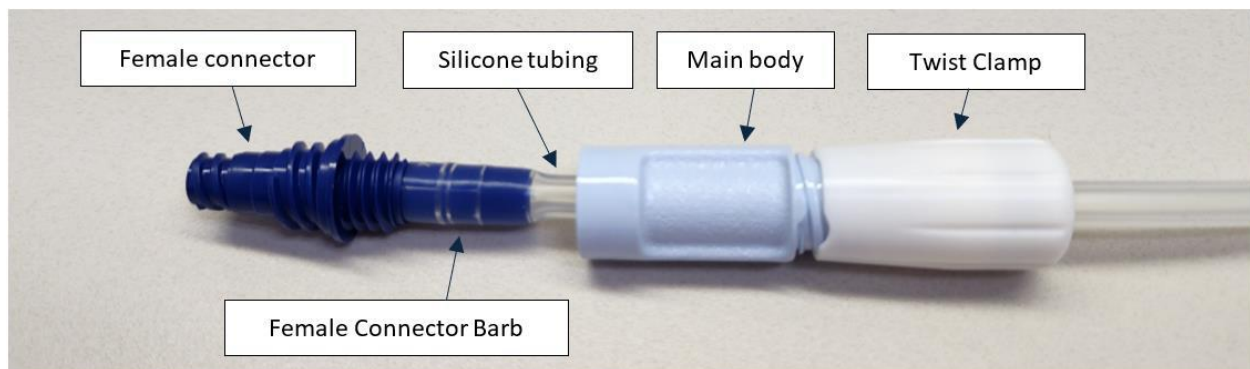
Figure 1. Example of a transfer set separation

Baxter Healthcare Corporation is issuing a Safety Alert for the MiniCap Extended Life PD Transfer Sets listed below due to an increase in complaints related to the separation of the female connector from the main body of the transfer set. See Figure 1 below, which illustrates an example of a separation between the dark blue female connector and the light blue main body of the transfer set in which the silicone tubing has become visible. These separations may occur while connecting or disconnecting from PD therapy products. However, as the tubing remains attached to the dark blue female connector during a separation, the sterile fluid path is maintained, and there is no risk of microbial contamination that will result from the separation itself.

Separation of the female connector from the main body of the transfer set would not directly lead to a breach in sterility of the fluid path. However, Baxter has received reports of patients subsequently cutting the patient line and/or not following aseptic technique when trying to address the separation. This may increase the risk of peritonitis. Baxter has received 6 reports of peritonitis that are potentially related to this issue.

1. **This is not a Recall; this is a Safety Alert communication.** If your transfer set is still intact and has not experienced separation issues, please continue to safely use the transfer set while following aseptic technique.
2. If you experience a separation of the transfer set, please close the transfer set twist clamp and do not cut the patient line. Contact your doctor and/or nurse **immediately** to arrange for a transfer set replacement and further guidance.
3. Complete the enclosed customer reply form and return it to Baxter by either scanning and e-mailing it to [\(insert local contact information\)](#) or sending it by post to [\(insert local contact information\)](#), even if you don't have any inventory. Returning the customer reply form promptly will confirm your receipt of this notification and prevent you from receiving repeat notices. [\(to be adapted locally\)](#)
