URGENT: FIELD SAFETY NOTICE – MDS-24-5154-C

4Fr Single Lumen PowerPICC (SOLO and non-SOLO versions)

Type of Action: Product Removal

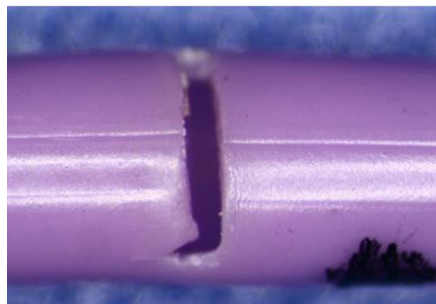
In March 2025, BD issued a global product removal due to an increase of material fatigue leaks on **4Fr single-lumen PowerPICC catheters**, both SOLO and non-SOLO versions, in specific geographies. These leaks are primarily characterised by a transverse/circumferential crack in the catheter tubing (Figure 1).

Figure 1: Example of transverse/circumferential crack in the catheter tubing

- The resin used to extrude the catheter tubing exceeded our supplier's specification for a material property called melt flow index (MFI). BD's investigation has concluded that a higher MFI could make the PowerPICC catheter tubing more susceptible to leakage when placed under stress.

- Insertion and securement techniques that contradict the PowerPICC IFU requirements, such as the requirement to insert the catheter as close to the zero mark as possible.

Consider the patient's infusion needs, alternative access options and the risks and benefits of continued catheter usage. BD is not recommending to explant product in-situ from any recalled lots unless catheter damage is suspected, as outlined below:

1. Carefully examine the visible portion of the catheter to assess for any sign of damage to the catheter shaft.
2. Monitor the patient closely for signs and symptoms of catheter damage, such as increased extremity circumference, infusate leakage, or reports of pain.
3. When using any BD PICC ensure practice is consistent with BD Instructions for Use for insertion depth and securement, including insertion to the zero mark. If the IFU for a securement device contradicts the IFU for the BD PICC, follow the IFU for BD's PICCs.

1. Immediately stop any infusion if catheter damage is suspected.
2. Follow your institution's guidelines for catheters with suspected damage.
3. If the catheter is confirmed to have a fracture, the catheter should be removed and an alternative route for access should be obtained.

- Cease use of any unused affected lot numbers of **4Fr Single Lumen PowerPICC**.
- Identify and quarantine all unused affected lot numbers of **4Fr Single Lumen PowerPICC**.
- Make a note of the lot numbers and immediately destroy all unused affected units.
- Complete and return the Customer Response Form **even if you no longer have any inventory remaining in your facility by 16th June 2025**.
- Circulate this notice to all those who need to be aware within your organisation or to any organisation where the potentially affected products have been transferred.

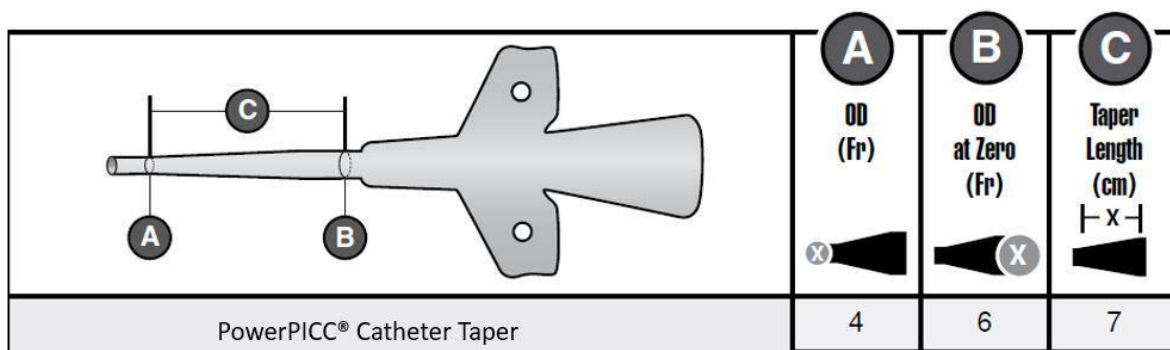
Figure 2: Image of the PowerPICC Taper Region

- BD PICCs have a taper design that increases in diameter near the zero-centimeter mark on the device.
 - When using any BD PICC, ensure practice is consistent with BD IFUs for insertion depth and securement, including insertion to the zero mark. Fully insert the PICC as close as possible to the zero-centimeter mark (position B in Figure 2). This allows the kink-resistant, tapered region to be utilised and is associated with lower catheter leakage rates.

- Select securement devices that can be used consistent with the BD PICC IFU.
