URGENT Field Safety Notice

Philips Allura Xper R7.6- R8.1 systems

Delay of installation of the Lifetime Extension (LTE) kit in Allura Xper R7.6-R8.1 systems may lead to a broken propeller motor clamping bolt and a broken X-ray tube locking bolt.

Date: 11-Nov-2024

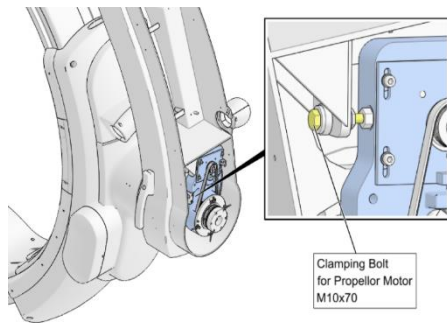
Philips has identified potential safety issues with delayed LTE kit installations for Allura R7.6-R8.1 systems exceeding 10 years of life. The kit includes a propeller motor clamping bolt (see Figure 1) and the X-ray tube locking bolt (see Figure 2). If one of these bolts breaks, part of the system will not function as expected.

If the installation of the LTE kit is delayed, breakage of the propeller motor clamping bolt and/or the X-ray tube locking bolt may be expected. If this occurs,

Figure 1: Clamping bolt of the C-arm propeller drive

A broken propeller motor clamping bolt could cause erratic C-arm movements, potentially resulting in the tube or the detector hitting staff or patients, leading to minor physical injuries (Example: hematoma/bruises, scratches, small cuts, or skin abrasions). Additionally, these erratic movements may trigger false collision detections, blocking all C-arm motorized movements and potentially delaying diagnosis or treatment.

Philips will contact all affected customers to arrange for a Field Service Engineer visit to install a Lifetime Extension Kit (reference FCO72200598). As of the date of this Urgent Field Safety Notice, Philips expects the solution to be available by Q1 2025.

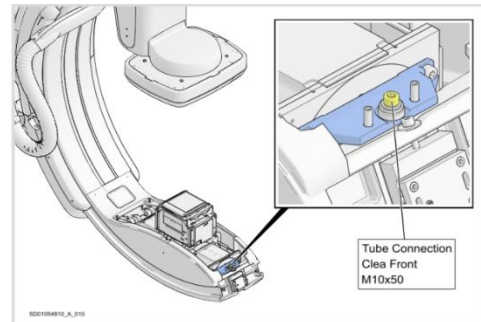
Figure 2: Locking bolt of the X-ray tube

A broken X-ray tube locking bolt could cause a black area to appear on the X-ray image, which may obscure the area of interest. This may require repeat imaging (up to 1 or 2 additional X-ray images or 3D scans), leading to additional radiation exposure. However, this additional radiation is not expected to exceed the thresholds for tissue reactions set by the International Commission on Radiological Protection (ICRP) for the risk of illness or injury.

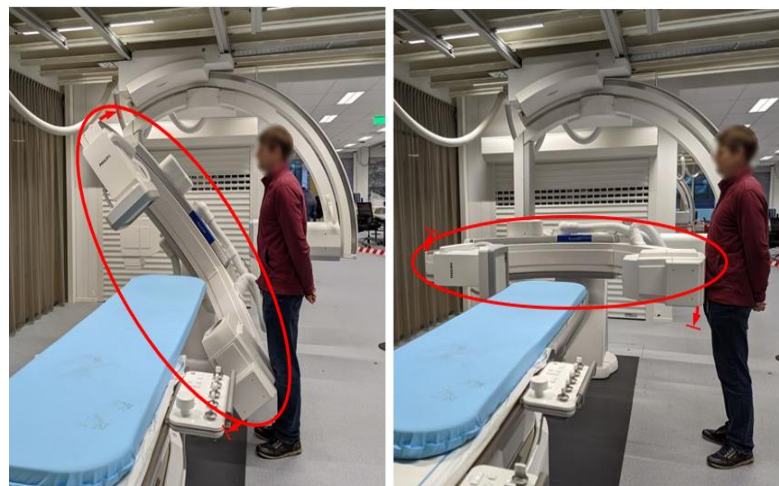
- The broken propeller motor clamping bolt may cause erratic C-arm movements, and potentially colliding with patients or bystanders (see Figure 3). These unbalanced movements may also cause the system to falsely detect a collision, consequently blocking motorized C-arm movements.
- The broken X-ray tube locking bolt may cause the tube to hit the cover, causing unexpected noise and the appearance of a black area (maximum up to 25%) on the X-ray image. Consequently, the area of interest in the X-ray image may be obscured, leading to the need for an additional scan.

Figure 3: Erratic movements of C-arm (red circle) due to broken propeller motor clamping bolt.
