URGENT FIELD SAFETY NOTICE

RE: THUNDERBEAT Type S Hand Instruments

Olympus reference: QIL FY25-EMEA-26-FY25-009- Thunderbeat Jaw Breakage Issue

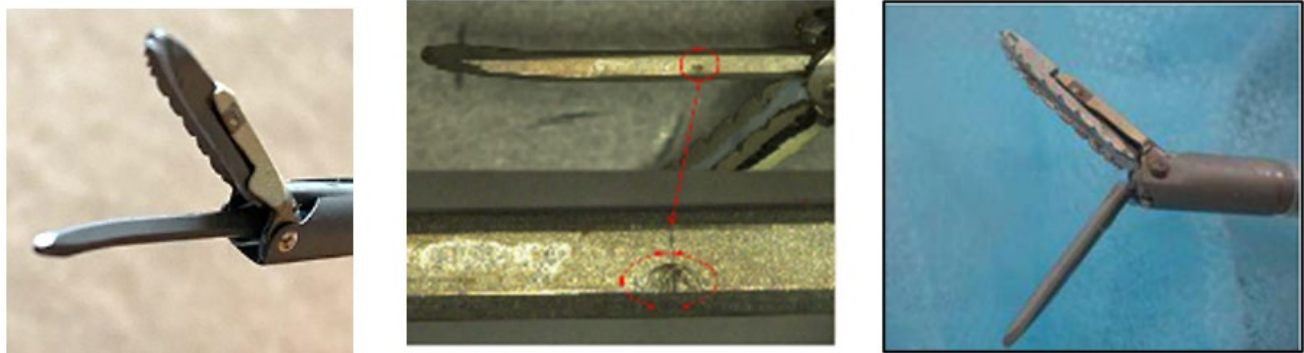
Olympus has been made aware, via customer feedback, of reports where probe tips of the THUNDERBEAT Type S Hand instrument are becoming damaged or are breaking (Reference example in Figure 1), as well as instances of pad damage or detachment (Reference example in Figure 2). These issues can occur when the instructions and warnings in the IFU are not followed, specifically, taking very large bites of tissue, contact with metal while activating, and activation without tissue between the jaws.

Figure 1. Example of Thunderbeat Probe in accordance with specifications (left), Cracked Probe (Center) and Probe Fracture (right)

Therefore, the purpose of this FSN is to reiterate the importance of these instructions and warnings to reduce occurrences of probe damage/breakage and pad damage/detachment. Please refer to Appendix 1 for excerpts from the IFU highlighting specifics around the warnings, errors and scenarios which can lead to these issues. Refer to the relevant IFU for the full content of the Instructions, Warnings, and Cautions to be followed.

In addition, Olympus strongly recommends the use of the ITM (Intelligent Tissue Monitoring) function to prevent probe pad damage due to over-activation, and therefore reduce the likelihood of probe tip damage. When using this function, the energy output automatically stops after the target tissue is divided. This is indicated by an audible signal/stop tone. Note: This function may need to be switched to 'on' on your generator, if not already enabled.

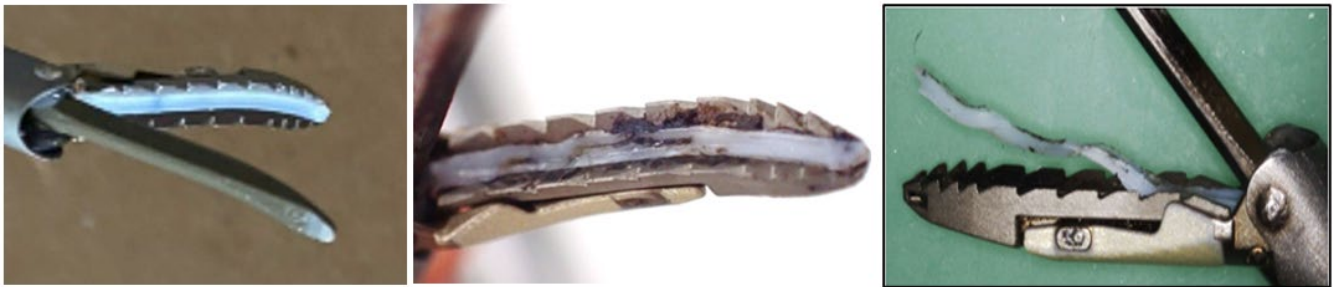
Figure 2. Example of Thunderbeat Probe in accordance with specifications (Left), Tissue Pad Deformation (Center), Tissue Pad Detachment (Right)
